Torsten Richter, Nabil A. Fouad

Guidelines for Thermography in Architecture and Civil Engineering

Theory, Application Area, Practical Implementation

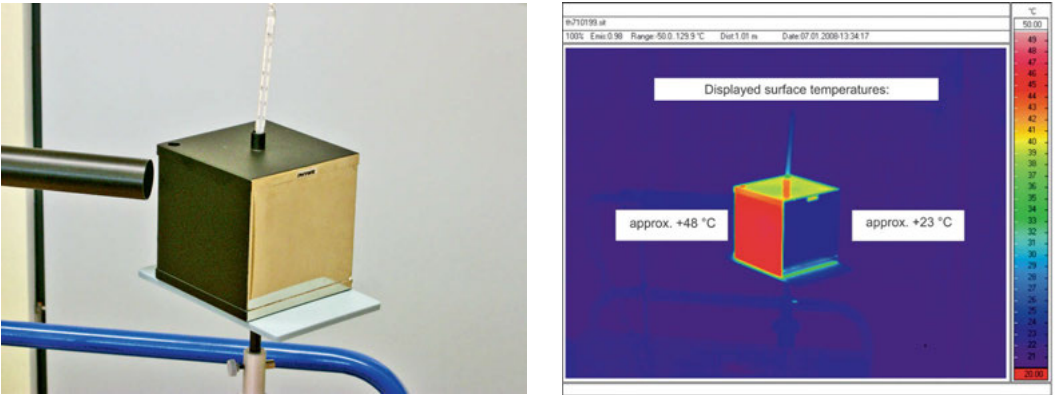
Fig. 2-9 Thermogram of a Leslie cube with a chosen global emissivity in order to illustrate the impact of different actual emissivity values of the surfaces. The surfaces of the cube have a steady temperature of about 48°C, but in the thermogram the temperature of the right side of the cube (polished metallic) is significantly lower than the actual temperature.

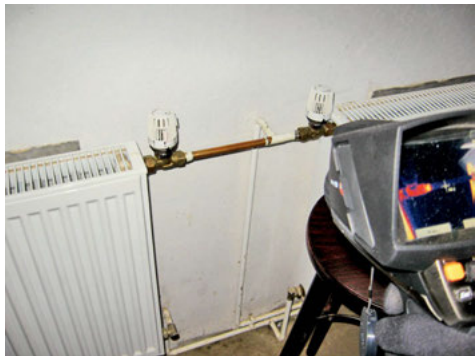
Fig. 2-10 Choosing a global emissivity doesn't represent the temperature correctly in this thermogram of a heating pipe due to the different real emissivity of the black- and white-coated pipe sections.

When using thermography in civil engineering, metallic features or window coatings can lead to false displayed temperatures due to their very different emissivity. A practical example of this problem is shown below: The thermogram reveals a significantly lower temperature along the heating pipe, but there is no temperature difference in reality. The problem is that the global emissivity is not suitable for the uncoated section of the pipe (see Fig. 2-10).

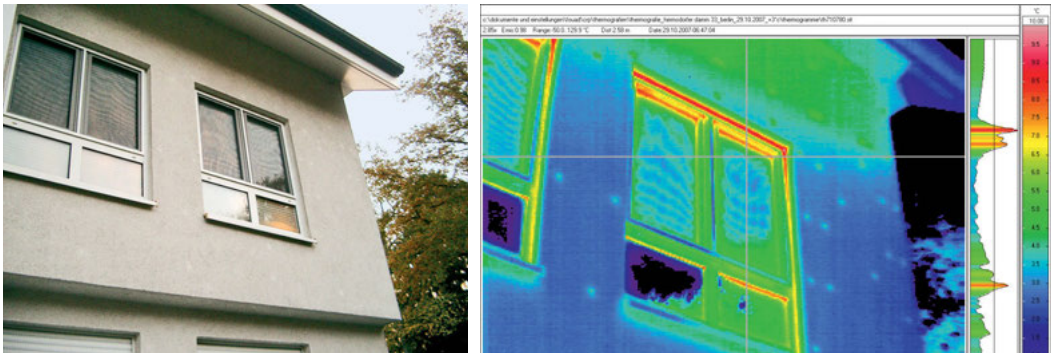
Fig. 2-12 Reflections on a window surface: The thermogram doesn't show the actual surface temperature of the window but rather the temperature of the atmosphere.

Normally reflections are easy to detect and/or to eliminate, when the object is thermo-graphed from various angles and changing shadows, or so-called hot spots, are observed due to a change in thermographing location. To do this, move the camera while thermo-graphing and follow the changes of the hot spot in the thermogram. If the hot spot moves synchronously with the camera movement and appears on several areas of the surface, a reflection can be assumed. Thereby it is easy to detect thermographs influenced by reflec-tions while measuring. However, it's much more difficult to identify reflections in the picture afterward.

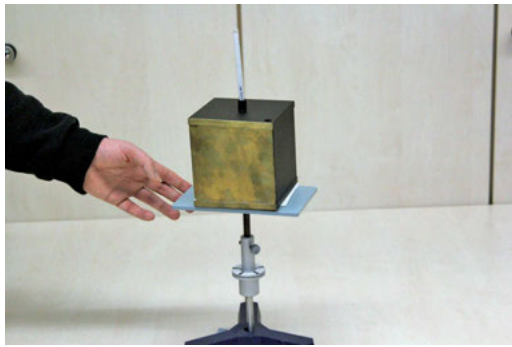
Fig. 2-16 – Part 1 Illustration of the impact of different observation angles on the temperature displayed: For retrograde calculation of the actual, real temperature, the correct emissivity is given.

Angle of observation: $\alpha = 80^\circ$
correct emissivity: $\varepsilon = 0.64$

By means of the abovementioned Leslie cube (Fig. 2-9), the practical impact of a changed emissivity due to the observation angle can be illustrated. The Leslie cube sits on a revolving mount; the black side is thermographed from different perspectives. The depicted temperatures are documented and the emissivity that shows the correct temperature is displayed (the real surface temperature is always the same, approx. 55°C). The emissivity exhibits the typical behavior of the graphs shown in Fig. 2-15 and Fig. 2-16.

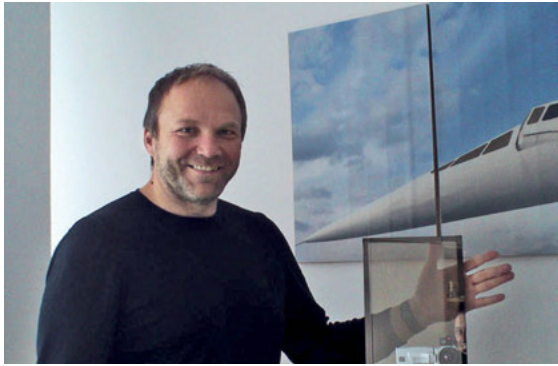
Fig. 2-17 Normal window glass is pretty much impervious to heat radiation; you can also see the thermographic camera mirrored in the image.

Glass is an important construction material which is often thermographed because of its use in windows. At this point it must be mentioned that glass is pervious to shortwave radiation but not to longwave heat radiation (see Fig. 2-17).

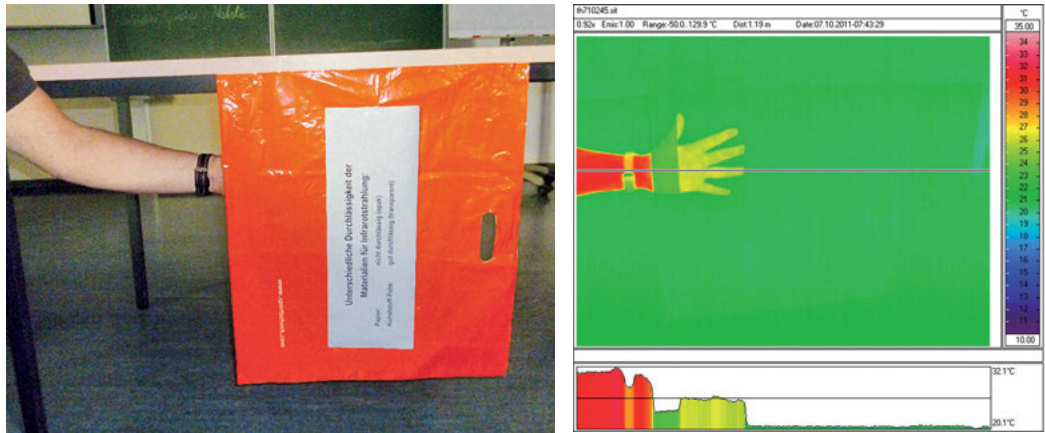
Fig. 2-19 Plastic films are often very transparent for infrared radiation; however, they are impervious for visible wavelengths.

While glazing is rather impervious for infrared radiation, thin plastic films may show high transmittances for infrared radiation. Construction sites provided with screens for visual protection could under certain circumstances also be thermographed. In most cases, the evaluation based on the experience of the human eye doesn't apply for infrared radiation (see Fig. 2-19).

In general, the objects analyzed by means of construction thermography can be considered as nontransparent ($\tau_M = 0$) to infrared radiation. (**Caution:** This does not apply for thin plastic films, gases and other transparent materials! See Fig. 2-19.) In the case of nontransparent materials, $T_{HS} = 0$, and equation (9) can be written as follows:

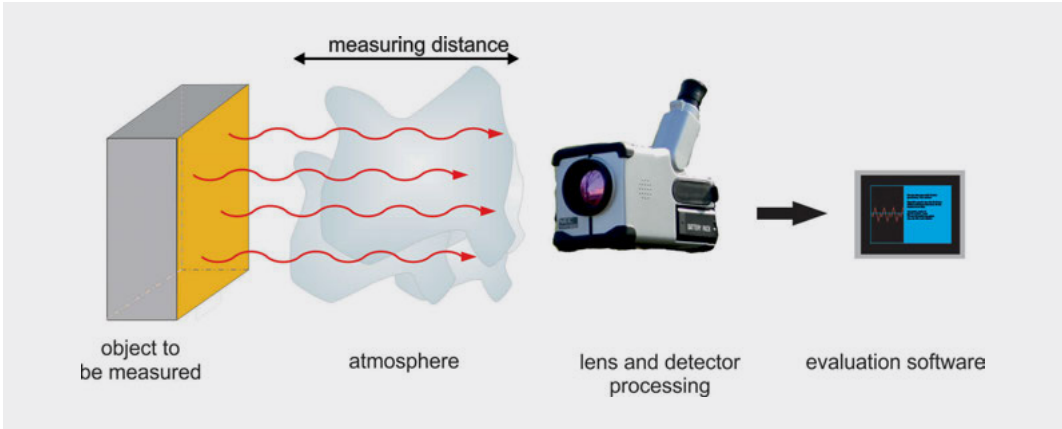
Fig. 2-20 Principles of noncontact thermography.

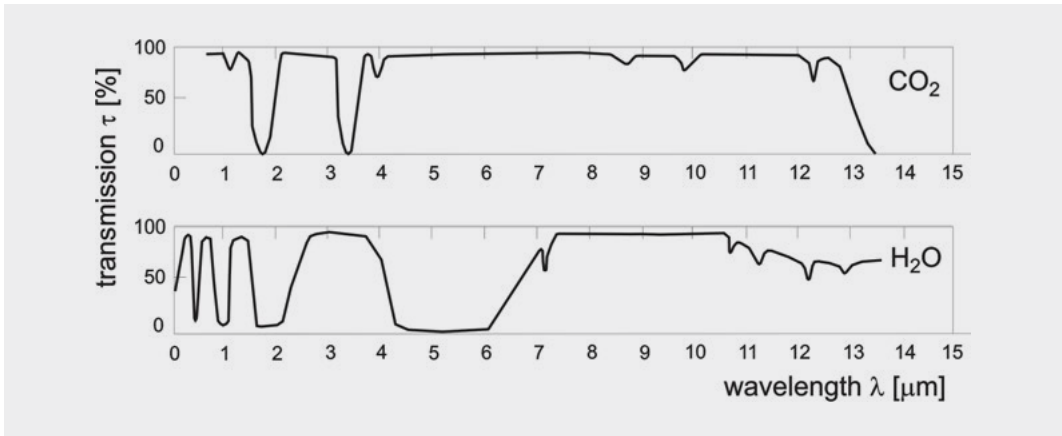
Fig. 2-21 Schematic illustration of the transmittance for CO_2 and H_2O in the form of air humidity for a measuring distance of about 300 m, taken from [41].

Fig. 2-21 shows a schematic illustration of the transmission behavior of carbon dioxide and humidity (water vapor) in dependency of the wavelength. The amount of CO_2 in the air is quite constant and so is its transmittance. However, since air humidity changes often, the transmittance is highly dependent on the present air humidity (amount of water vapor).

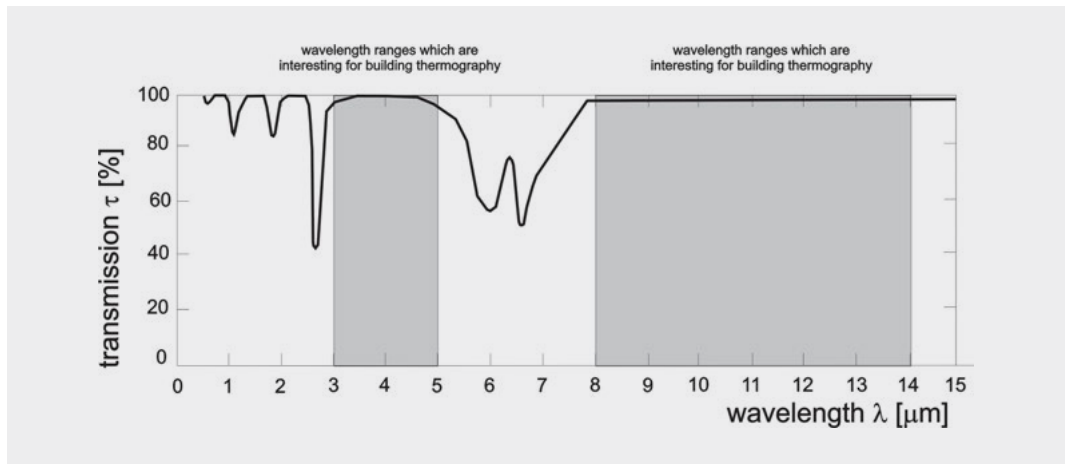
Fig. 2-22 Schematic illustration of the transmittance of a 1 m measuring distance, with an air temperature of 32°C and a relative humidity of 75%.

Furthermore, Figs. 2-22 and 2-23 reveal that there are wavelength ranges within the infrared spectrum in which the transmission is constantly very high without any significant absorption property. These areas are called *atmospheric windows* and mark the sections in which emitted radiation faces very little damping on its way through the atmosphere. By chance,

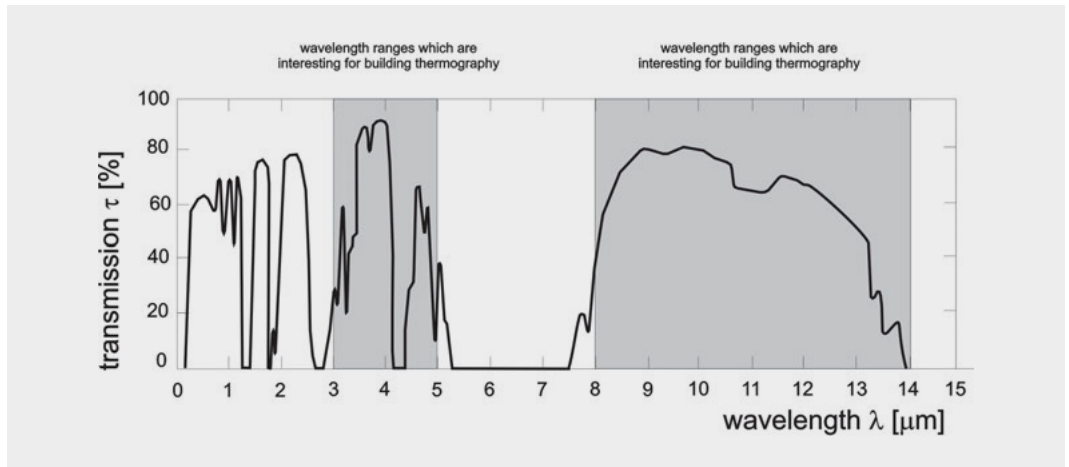
Fig. 2-23 Schematic illustration of the transmittance of a 2000 m measuring distance, with an air temperature of 15°C and a relative humidity of 75%.

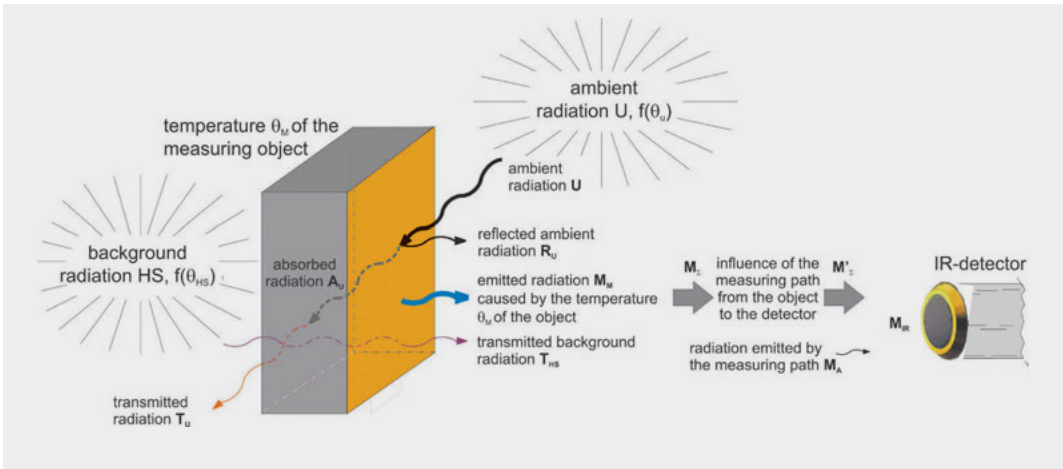
Fig. 2-24 Schematic illustration of the shares of radiation in a thermographic measurement setup.

For a real temperature measurement, the laboratory conditions of a black radiator are not given. As depicted in Fig. 2-24, different shares of the radiation influence the radiation signal that is finally detected by the sensor.

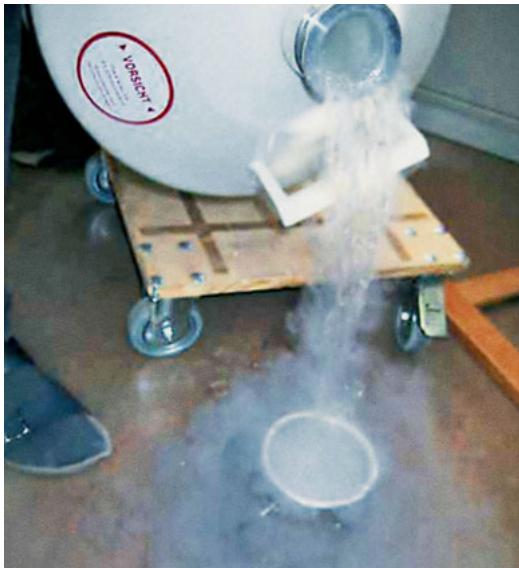
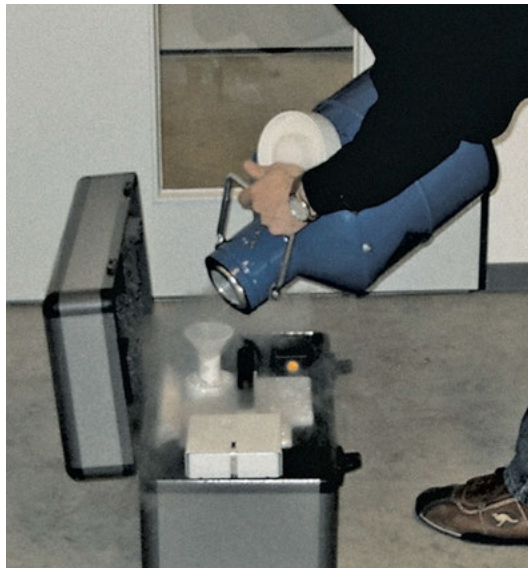
Fig. 3-2 Cooling with liquid nitrogen: A portable tank is filled with liquid nitrogen from a storage tank (*left*) and used to fill a thermography camera (*right*).

Liquid nitrogen is commonly used in construction thermography. Liquefied gases are filled into a Dewar flask.³ The detector that is to be cooled sits on the bottom of the Dewar flask, positioned behind an infrared-pervious screen so radiation can get to the detector. The evaporation heat of the liquid gas keeps the receiver constantly at the boiling point ($-196^{\circ}\text{C} = 77\text{ K}$ for nitrogen). One disadvantage of this method is the handling of the liquid gas (transportation and storage) and the compulsory upright position of the Dewar flask, which restricts the view. Scanning an object from a slanted angle of view, as is often necessary in construction thermography, is not possible. Liquid gas cooling allows a usage time of about four to ten hours for most thermography cameras.

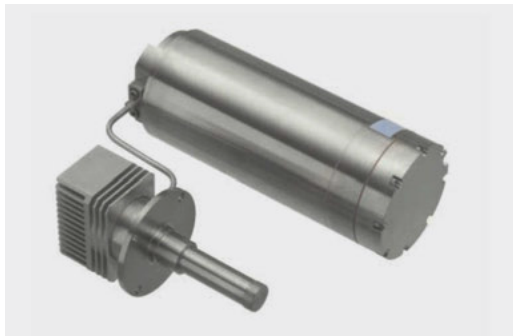
Fig. 3-3 Stirling cooler: linear-driven, split model (Image: Fa. AIM GmbH, Heilbronn 2003), 1.5 Watts refrigerating capacity (left: cold tip = cold finger, Ø 13.7 mm).

The Stirling cooler is a mechanically driven cooling machine that generates cold by thermodynamic cyclic processes. The invention of the Stirling cooler was primarily advanced by the military and the aerospace industry. In order to reduce vibration load, Stirling coolers are equipped with a linear drive. Furthermore, the operation chambers are split so that the cold is generated in only one of the two cylinders ("cold finger"). The working gas is transported between the two cylinders by a connection pipe. Fig. 3-3 exhibits such a split Stirling cooler. Stirling coolers generate a refrigerating capacity of 1–2 Watts out of a consumption power of 40–90 Watts. When bringing a thermography camera equipped with a Stirling cooler into service, it takes about ten to twenty minutes to generate the operating temperature (77 K). Due to the mechanical wear of Stirling machines, the operating time of such a cooler is about 50 000 to 60 000 hours.

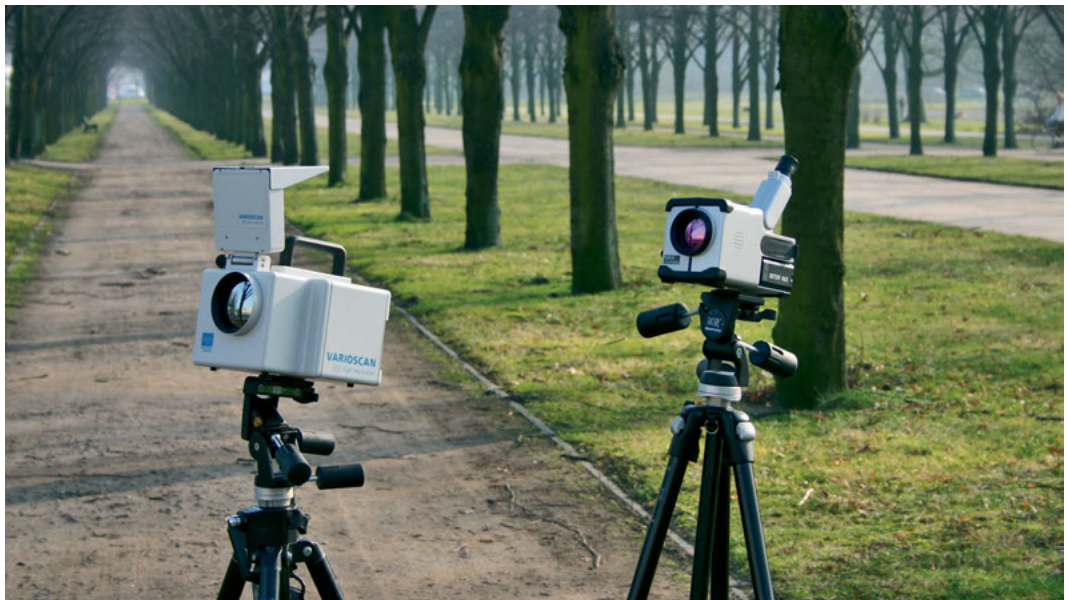
Fig. 3-9 Comparison measurement with thermography cameras: (left) scanning single-element camera equipped with a Stirling cooler; (right) uncooled micro-bolometer camera, with 320 × 240 pixels resolution (state-of-the-art in 2001).

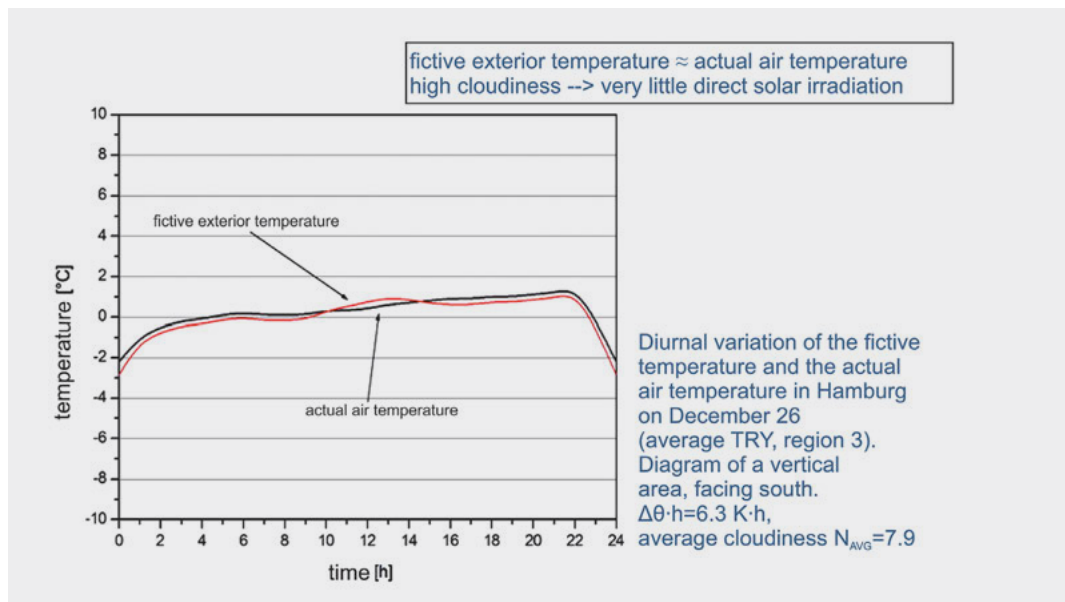
Fig. 5-1 Sequence of the fictive exterior temperature to the actual exterior temperature, example of a heavily overcast day.

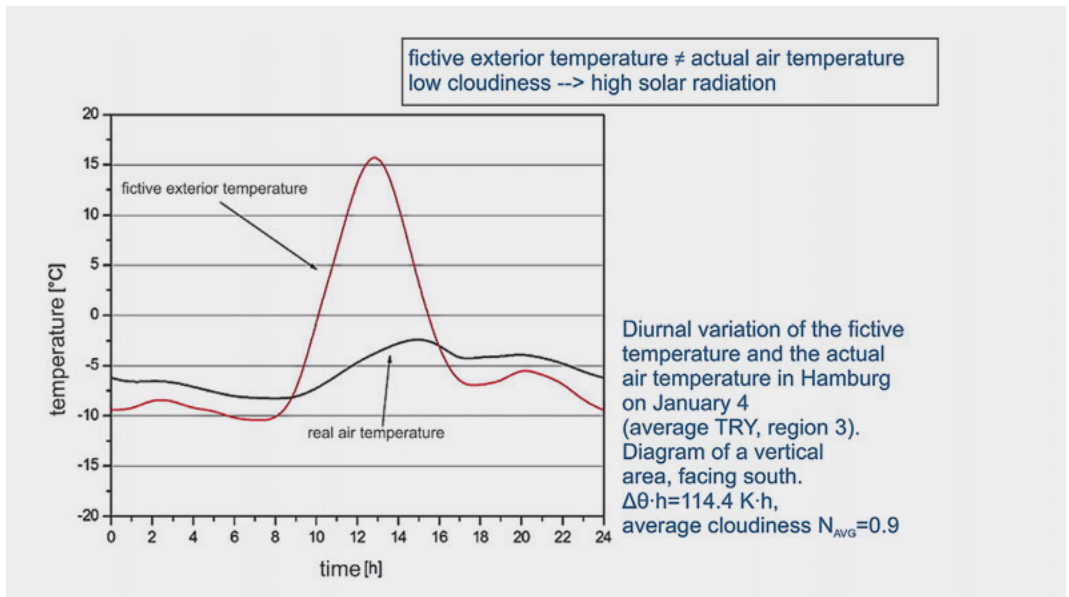
Fig. 5-2 Sequence of the fictive exterior temperature to the actual exterior temperature, example of a slightly cloudy day.

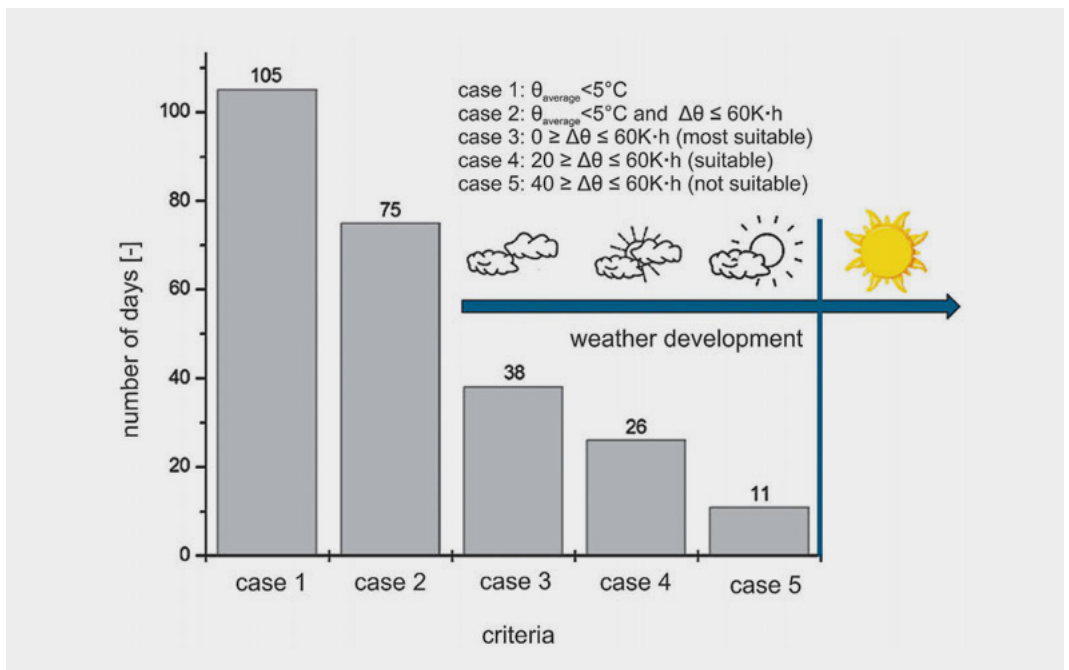
Fig. 5-3 Distribution of suitable days for thermography measurement and corresponding weather development.

Practice has shown that stable (bad) weather with constant temperatures around 0°C and overcast sky are very good conditions for thermography measuring. Analyzing Fig. 5-3, such weather conditions are given on 38 single days.

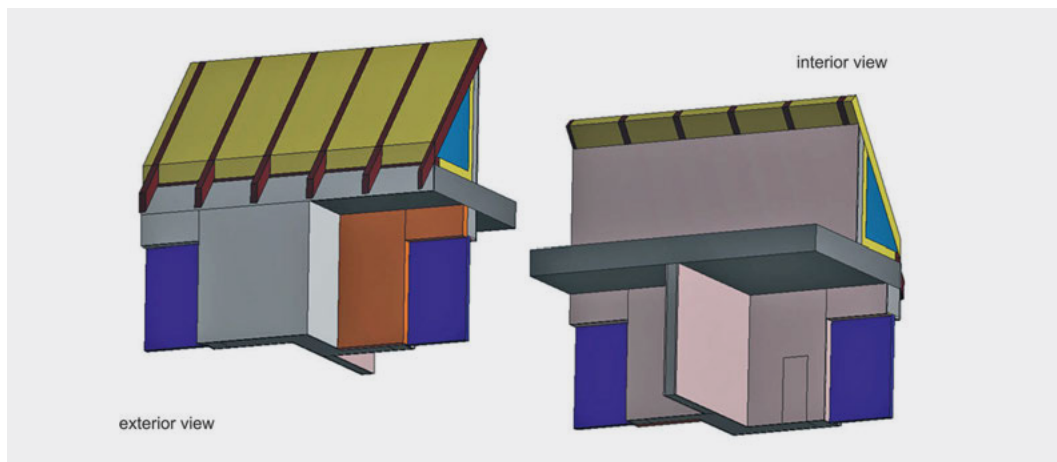
Fig. 5-4 Interior and exterior views of the FE-model of the construction (FE-software: Ansys-Workbench).

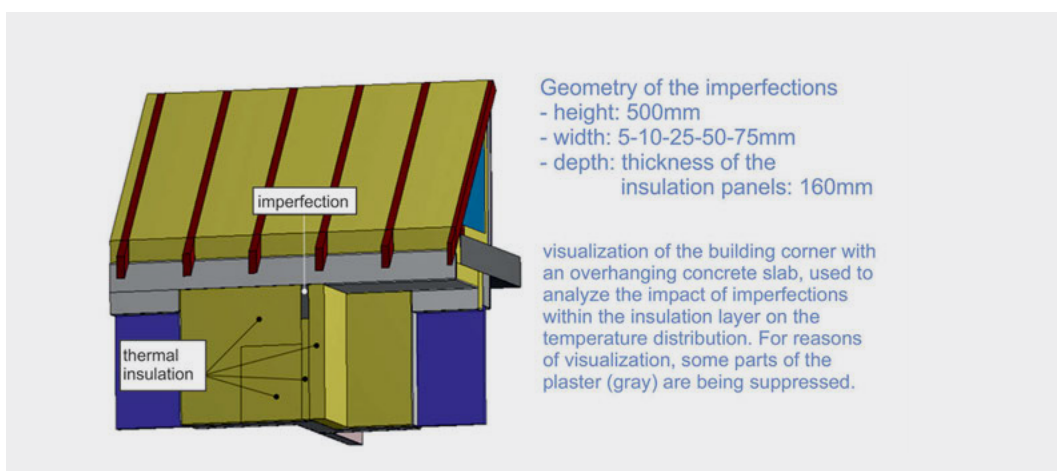
Fig. 5-5 Exterior view of the FE-model with position of the assumed imperfection within the plane of the thermal insulation composite system (software system: Ansys-Workbench).

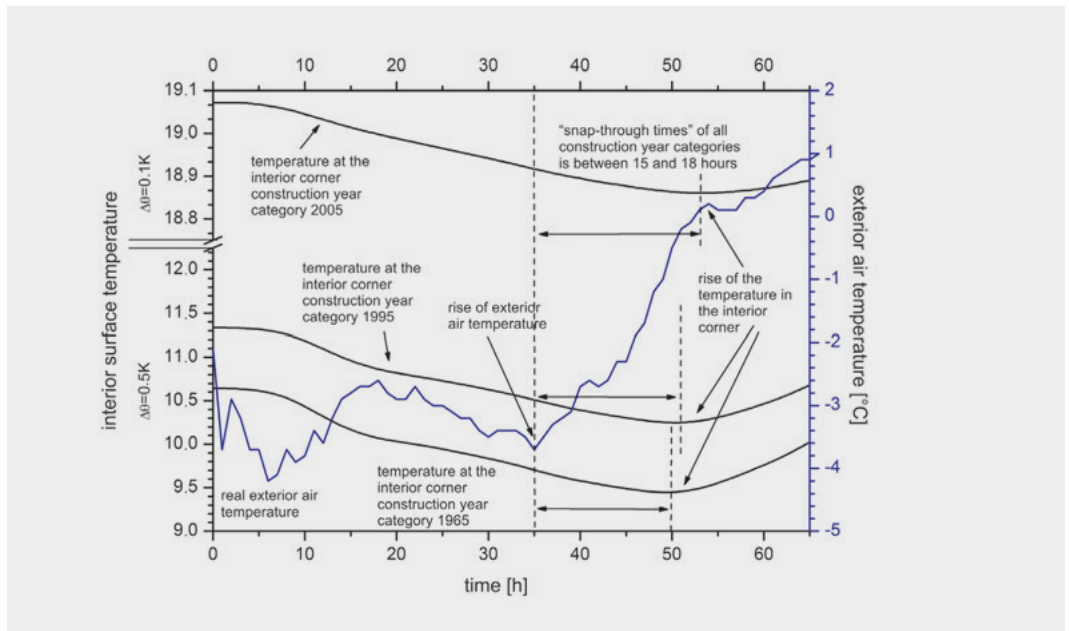
Fig. 5-7 Delayed temperature reaction of the interior corner of the ceiling to the rise of the exterior temperature. Very well-insulated constructions exhibit higher interior surface temperatures and lower thermal fluctuation throughout the day.

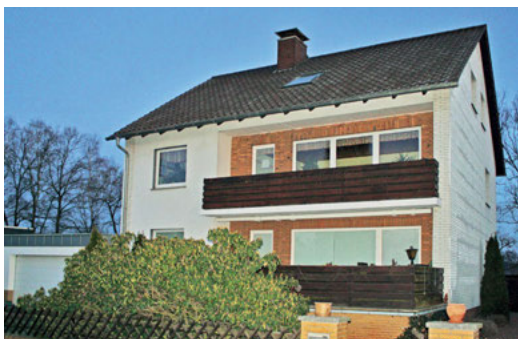
Fig. 5-15 Exterior perspective of the building, measuring of the surface temperature in the exterior ceiling corner (left side of the balcony on the upper floor) by means of a contact thermometer; displayed measuring value: $\theta_{se} = 11.1^\circ\text{C}$.

An outdoor thermography was performed on the thermal bridge discussed in Chapter 7.1.1. The surface temperature at the interior ceiling corner was measured by means of a contact thermometer. The surface temperature θ_{si} of the corner at the time of the thermography measurement was about 11.2°C (see Fig. 5-15).

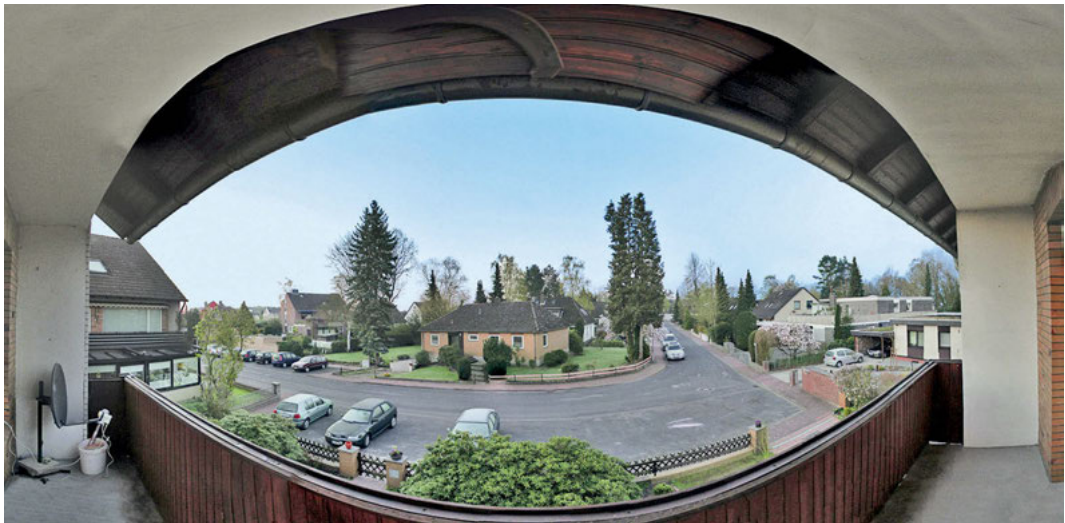
Fig. 5-17 Thermogram used to determine the ambient radiation temperature, half-space image taken in front of the wall that is to be measured by means of thermography; ambient radiation temperature: $\theta_u \approx -20.0^\circ\text{C}$. The evaluation point of the thermograms depicted in Fig. 5-16 is on the very right edge of this photograph.

For the situation depicted in Fig. 5-17, the ambient radiation temperature θ_u was determined to be about -20°C. For common emissivity of the material surfaces ($\varepsilon = 0.90$ – 0.98) and an estimated ambient radiation temperature $\Delta\theta_u$ of ± 20 K compared to the real ambient radiation temperature θ_u of -20°C, an effective range of the displayed surface temperatures of $\Delta\theta < \pm 2$ Kelvin compared to the actual surface temperature can be reached.

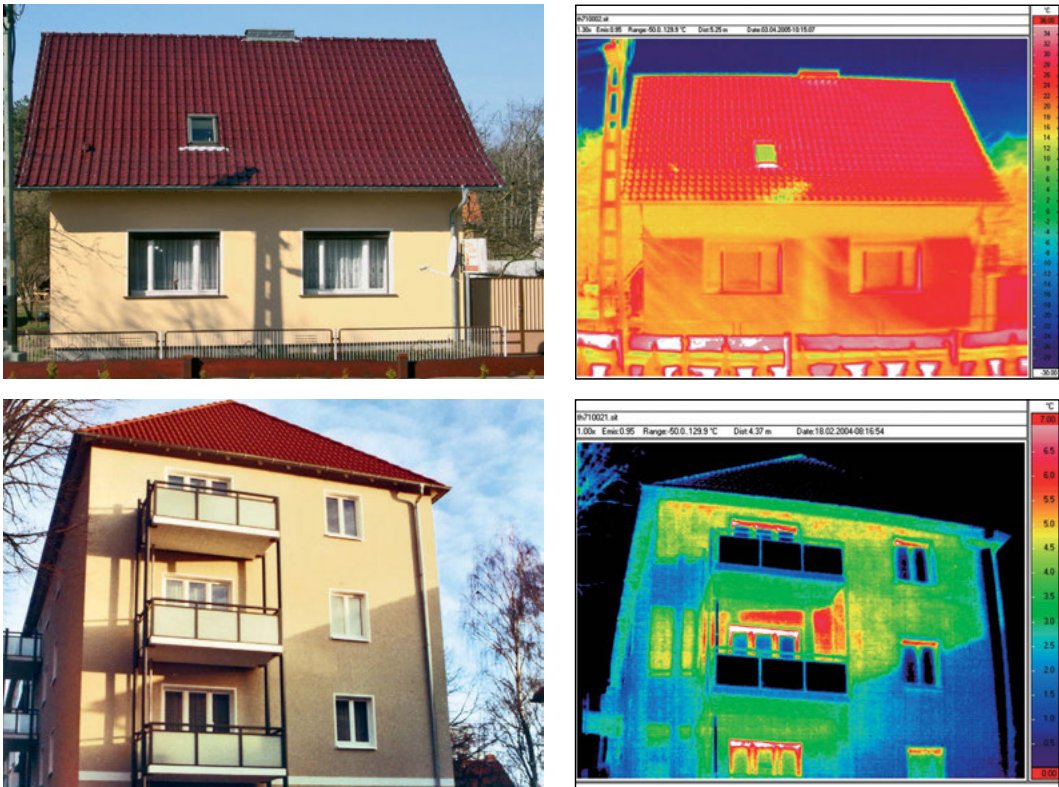
Fig. 6-1 Examples of how it should not be done: Impacts of shadows and direct solar radiation on thermography images.

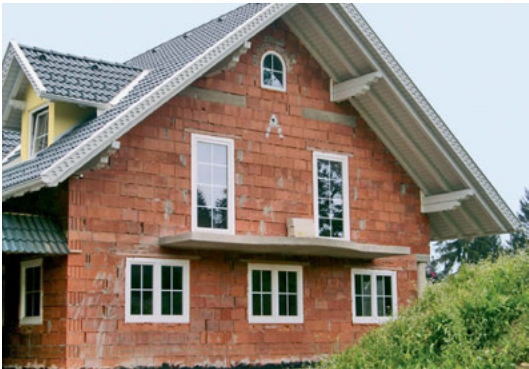
Fig. 6-5 Typical example of a potentially critical thermal bridge: cantilevered reinforced concrete slab of a balcony, in this case without correct thermal isolation.

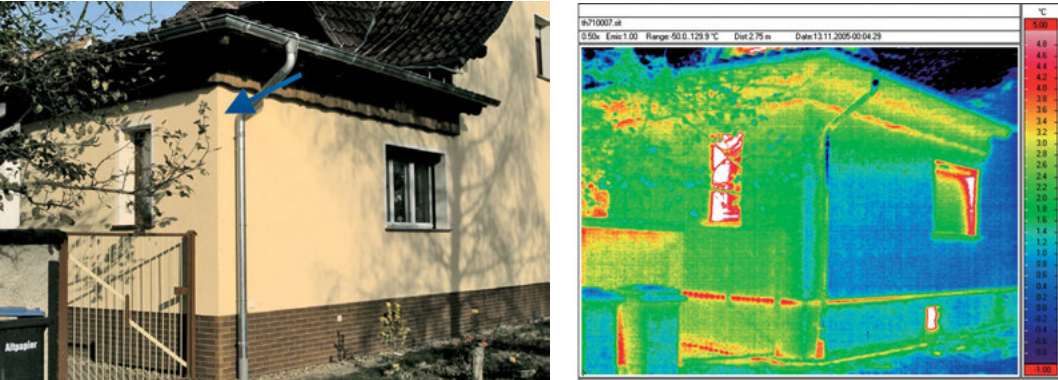
Fig. 6-6 Corner of a building with a thermal insulation composite system and free from defects (thickness of insulation layer: 10 cm, WLG 040, according to German classification).

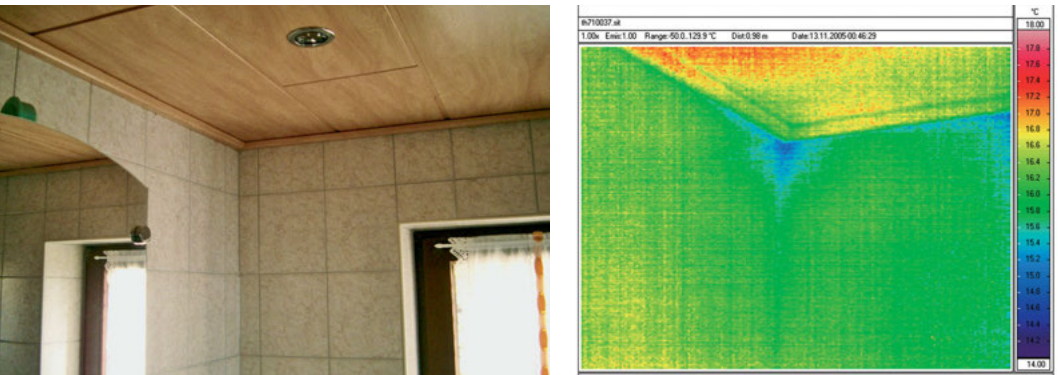
Fig. 6-7 Interior view of the defect-free corner of the exterior wall depicted in Fig. 6-6.

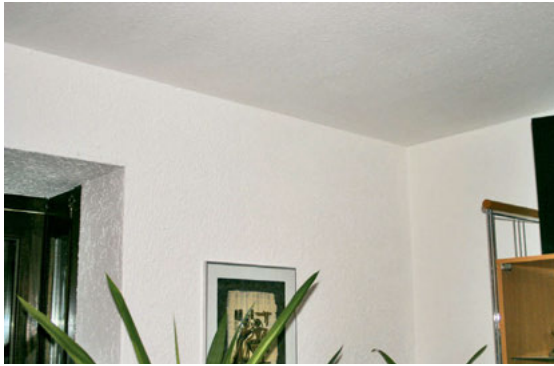
Fig. 6-8 Corner of a defect-free exterior wall with corresponding thermogram.

Fig. 6-8 shows another example of an uncritical corner of an exterior wall. The temperature in the corner is about 3 Kelvin lower than the temperature of the undisturbed wall. However, it increases promptly with the distance from the corner.

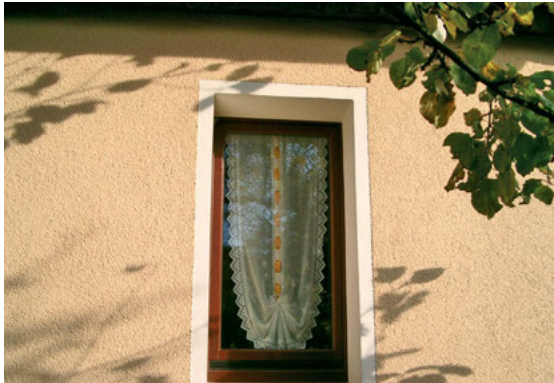
Fig. 6-9 Exterior view of a wooden window construction and its corresponding thermogram: in the thermogram the mounting screws of the thermal insulation composite system become visible.

At this point it has to be mentioned that in this case, the significant heating of the lintel and the top of the window frame shown in Fig. 6-9 is due to the bathroom window having been open until about half an hour before the beginning of the thermography measurement. Thus, in practice, it is very important to consider the boundary conditions at the time of the thermography measurement and prior to it. Furthermore, some irregularities can be explained by querying the user or occupant, as in the example of Fig. 6-9.

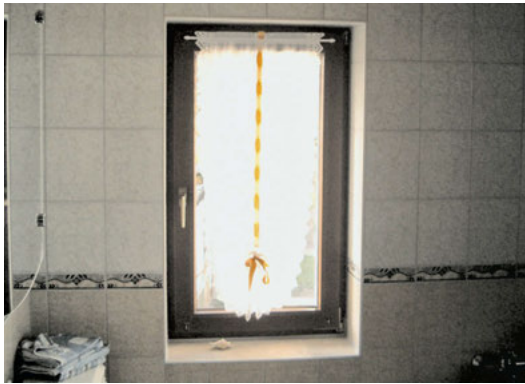
Fig. 6-10 Indoor thermography of the window construction from Fig. 6-9: the interconnection between the glazing and the window frame stands out as a cold area.

Windows are generally the part of the construction that has a lower thermal insulation than the exterior walls, both for old and new buildings. Especially the window frame and the thermal problematic interconnection between the glazing and the frame stand out in thermograms (such as in the indoor thermogram depicted in Fig. 6-10). Furthermore, air on the exterior of the windows heats up and accumulates under the edge of the wall, which for relatively windless conditions leads to a typical warming of the lintel.

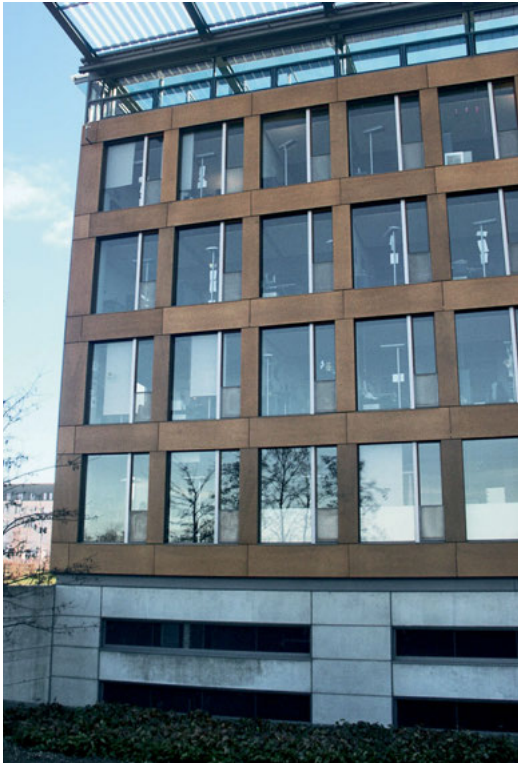
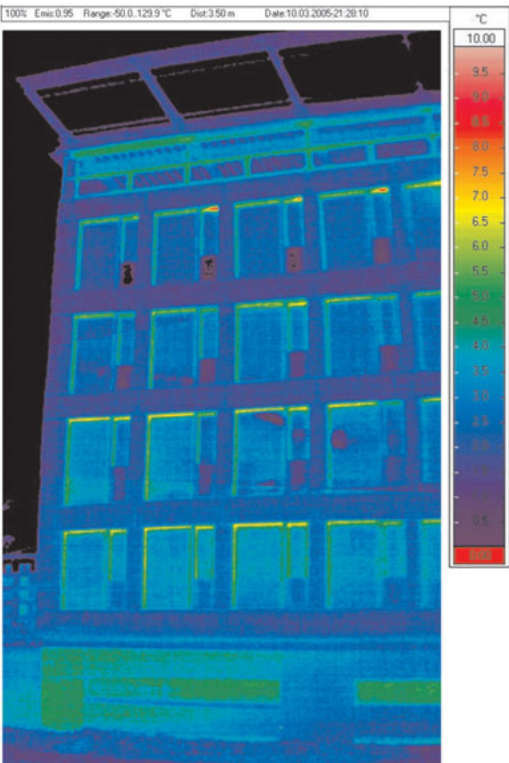
Fig. 6-11 Extensive window construction in an office building: the common thermography image shows windows that are thermally free from defects.

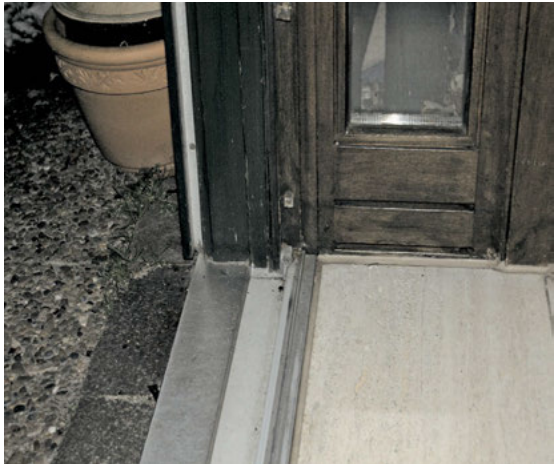
Fig. 6-12 Thermally isolated threshold of a terrace door.

The thermal isolation of construction parts from the outdoor area is especially important for building parts with high temperatures (isolation of heated screeds) or building parts with high thermal conductivity (thermal isolation of steel beams). Fig. 6-12 shows an example of an ideally thermally isolated threshold of a terrace door. In the thermogram, the effectiveness shows in the steep decrease of the temperature at the threshold. An example of a poorly implemented thermal isolation of a steel beam is shown in Chapter 7.1.3.

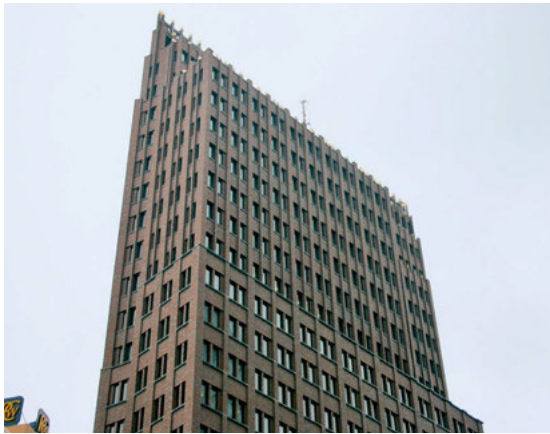
Fig. 6-13 Facade of a high-rise building; hot spots indicate open windows.

With the aid of imaging thermography, exterior wall constructions can quickly be examined with regard to their thermal behavior. The following figure shows the facade construction of a high-rise building. The exterior wall surface exhibits a uniform temperature level throughout, without any defects. Local temperature peaks (so-called hot spots) indicate windows that were open during the thermography measurement.

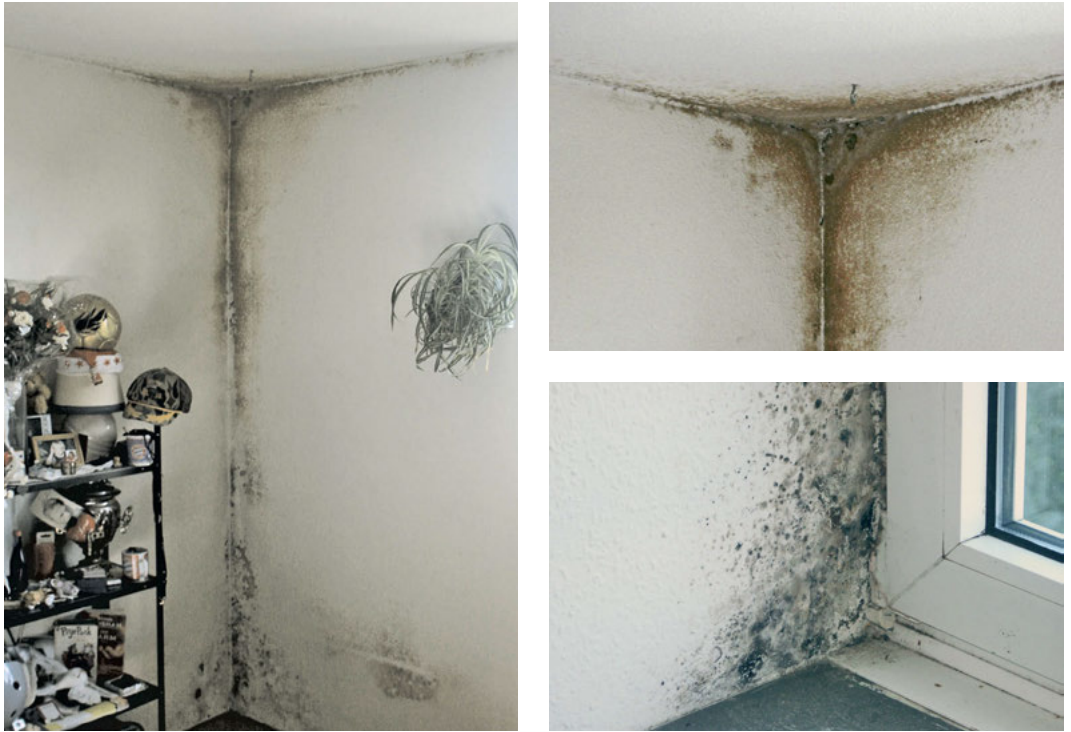
Fig. 6-15 Extreme mold formation on the inside corner between exterior walls and the ceiling and along the window soffit.

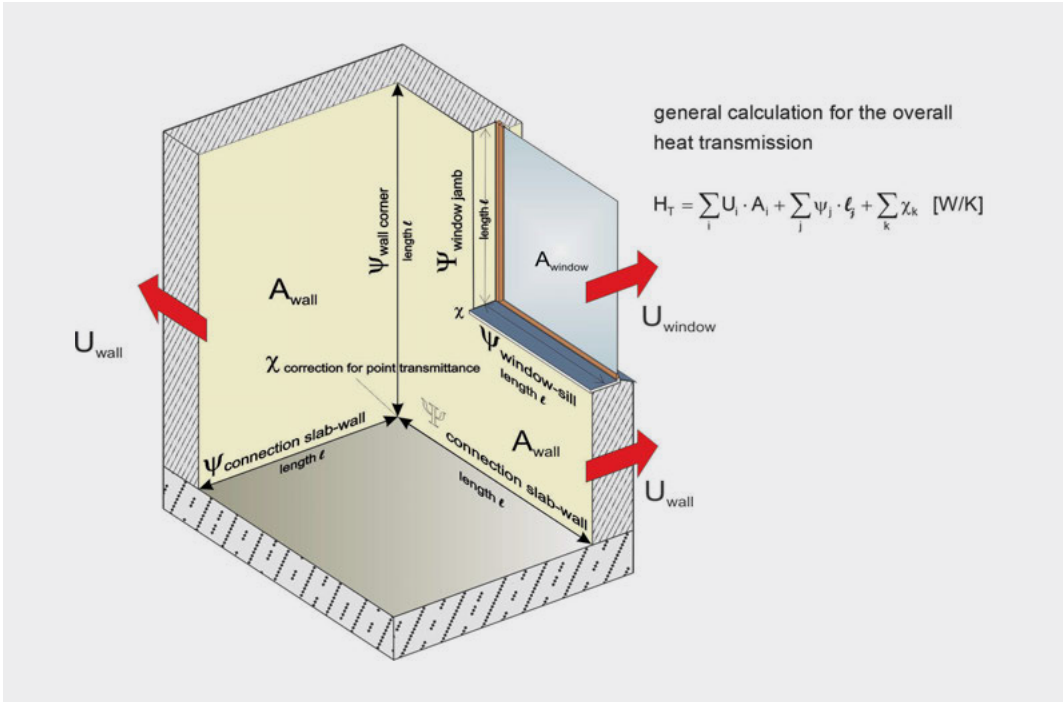
Fig. 6-16 Application of thermal bridge loss coefficients taking account of the heat loss caused by thermal bridges, illustrated by means of a wall-to-ceiling connection.

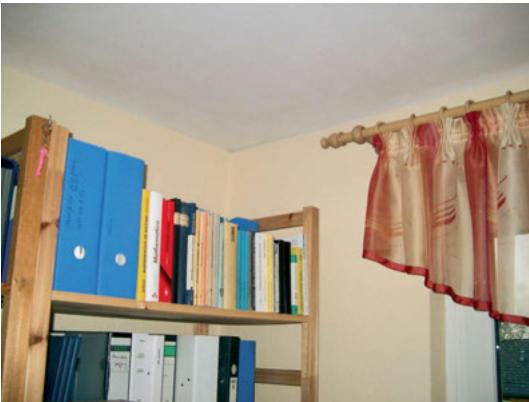
Fig. 7-1 Exterior wall corner region with beginning mold.

The thermal image taken from indoors shows a significant cooling of the wall areas close to the ceiling and the neighboring ceiling areas (the difference to the undisturbed wall construction is about 5 Kelvin). The reason for this significant cooling on the interior wall surface is the geometric design of the construction in the corner region. In addition to the unavoidable geometric thermal bridge of the corner region, the concrete ceiling is not thermally isolated from the adjoining exterior wall (see Fig. 7-3).

The renters were advised to move the shelf further away from the corner region (see Fig. 7-1). Through this measure, the heat transmission resistance on the inside was decreased, which led to a better heating of the interior corner region.

The corner area in **Fig. 7-1** was thermographed again in November 2016 and shown in **Fig. 7-5**. In addition to the conspicuously clearer image due to the higher geometric resolution (1024 × 768 pixels compared to the original image's 320 × 240 pixels in **Fig. 7-2**), almost the same temperature differences are determined at the evaluation points.

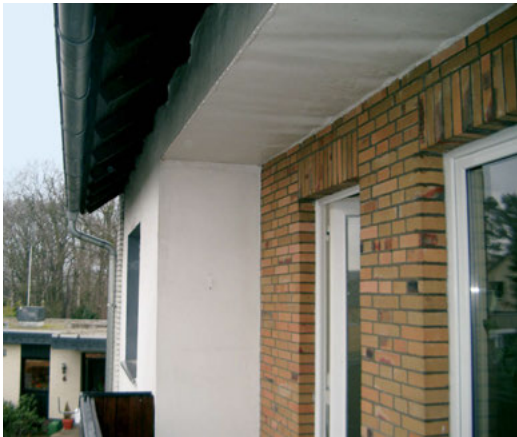
Fig. 7-3 Exterior view of the balcony with the traversing concrete ceiling.

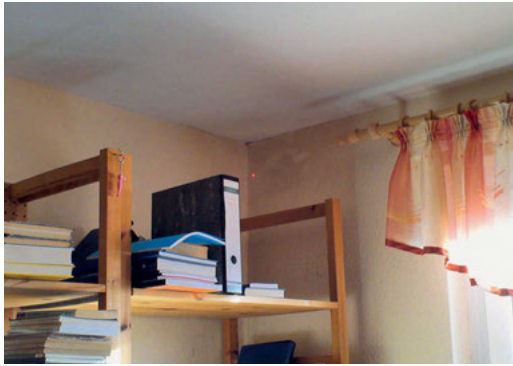
Fig. 7-5 Thermogram of the wall-corner area already shown in **Fig. 7-2**. The difference between the 3D-Ixel and the almost undisturbed wall area (1D) is similar to the thermogram in **Fig. 7-2** from 2004 (about 5 Kelvin), thermogram shot with a camera with a significantly higher geometric resolution.

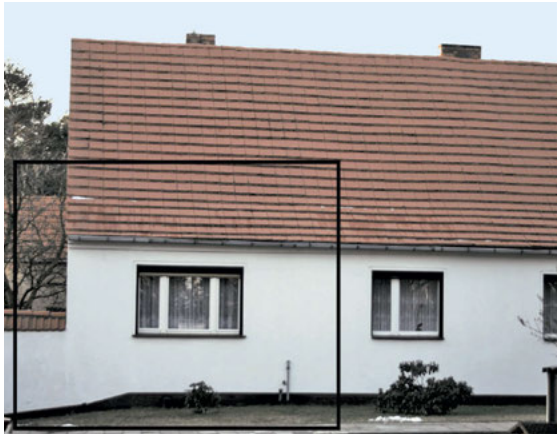
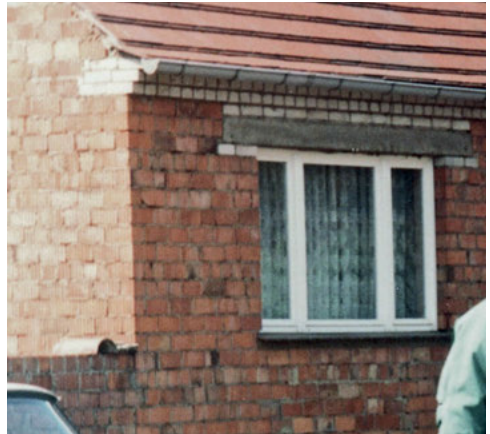
Fig. 7-6 Masonry construction with uninsulated lintel (reinforced concrete); (right) photograph taken during the construction process (approx. 1986) showing the position of the window lintel made of concrete.

A typical material-related thermal bridge exists when there are construction elements with different thermal conductivities (see **Chapter 6.2.1**). A typical example of this is an uninsulated concrete window lintel. Such a construction element is shown in **Fig. 7-6** as well as in **Fig. 7-7** as a thermal image.

In addition, **Fig. 7-8** shows a thermogram of the same section of the building taken at a different time with a state-of-the-art detector format of 1024 × 768 infrared pixels (camera: InfraTec VarioCam HD). With the higher resolution, significantly sharper and more detailed thermograms with more information content can be achieved. Thus, the dimensions of the masonry used can also be seen in the thermogram (see in particular **Fig. 7-6, right**).

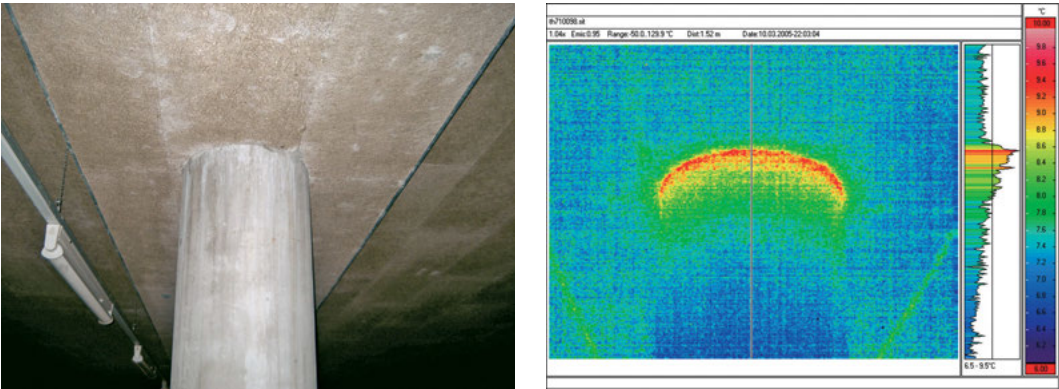
Fig. 7-12 Concrete pillar traversing the thermal insulation layer.

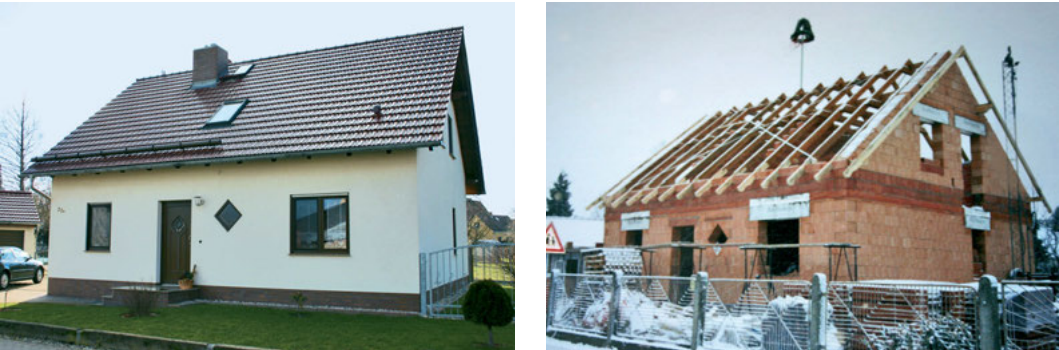
Fig. 7-13 Residential building at the time of the thermography measurement (*left*) and at the time of construction (*right*): above the windows, insulated roller blind boxes and the circular ring beams (U-shaped shells with reinforced concrete, see Fig. 7-20) are located.

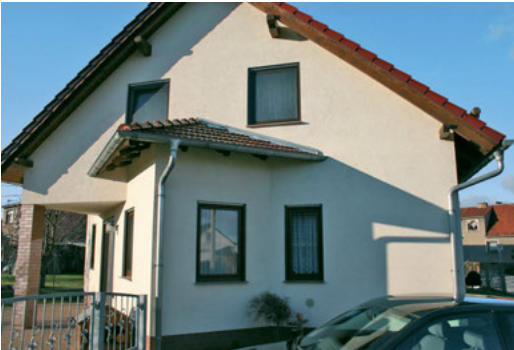
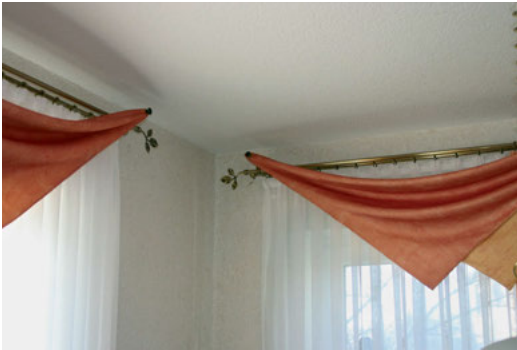
Fig. 7-15 Triangular annex of the building; (right) interior view of the protruding corner region.

Further analysis has been conducted on the same building at a triangular protruding extension of the building. As illustrated in Fig. 7-15, the building was under direct solar radiation when the thermography measurement was conducted. As already explained in Chapter 6.1.1, outdoor thermography is not meaningful under such circumstances. The thermal image of the wall-to-ceiling crossover was therefore taken from the inside and is shown in Fig. 7-16.

The decrease in the surface temperature at the ceiling could be explained by a lack of thermal insulation, which wasn't installed over the whole area of the solid ceiling (see Fig. 7-15). Thus, cold outdoor air could undercut the existing thermal insulation and effectuate a cooling of the ceiling.

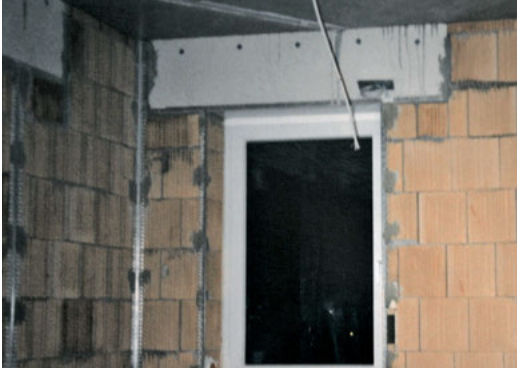
Fig. 7-17 Photo of the examined wall region taken during the construction process.
