Torsten Richter, Nabil A. Fouad

Guidelines for Thermography in Architecture and Civil Engineering

Theory, Application Area, Practical Implementation

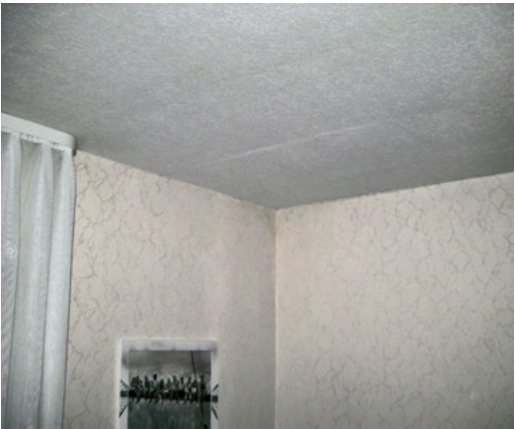
Fig. 7-18 Corner region of an exterior bedroom wall.

In a bedroom of a residential building, the renter complained about beginning mold formation. In addition to an evaluation of the heating and aeration behavior and analysis of the building construction, a thermal image was taken during the cold season in the frame of an expert opinion. The evaluation of the thermal image exhibits a conspicuously continuous and uniform cooling in the corner region between the ceiling and the exterior wall. Such uniform temperature differences between the undisturbed wall and its connection to the ceiling can be taken to indicate a constructive anomaly. Together with the builder-owner, the

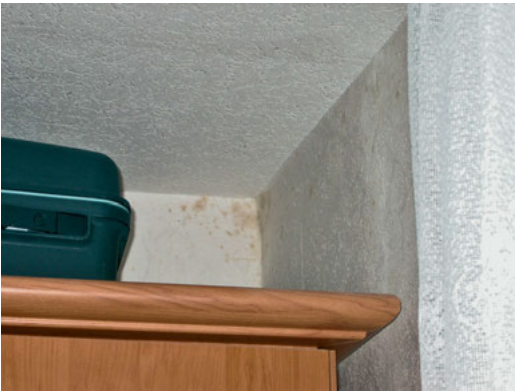
Fig. 7-19 Beginning mold formation in the corner region.

Hence, even with proper heating and aeration behavior, the accumulation of condensate and formation of mold can't be completely eliminated. In this case the cause of the mold formation is the ring beam region, which had not been thermally insulated during the construction process.

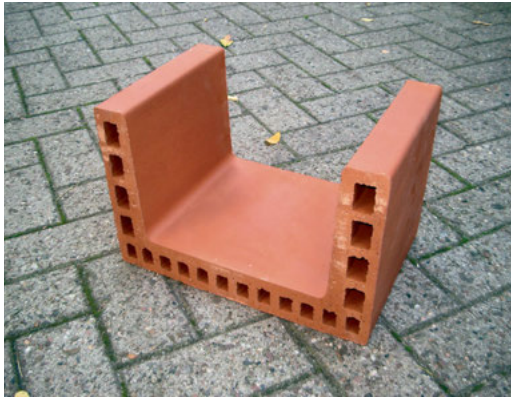
Fig. 7-20 Available shapes of U-shaped shells; (right) shell with factory-made thermal insulation.

structure of the construction in the critical area was examined more closely. Evaluating the construction plans revealed that in the exterior section, a continuous ring beam had been arranged on top of the Porotherm blocks (known as “Poroton masonry” in German-speaking countries) inside a U-shaped shell. However, the U-shaped shell had been completely filled with concrete and had not been additionally insulated on the outside, as had been planned.

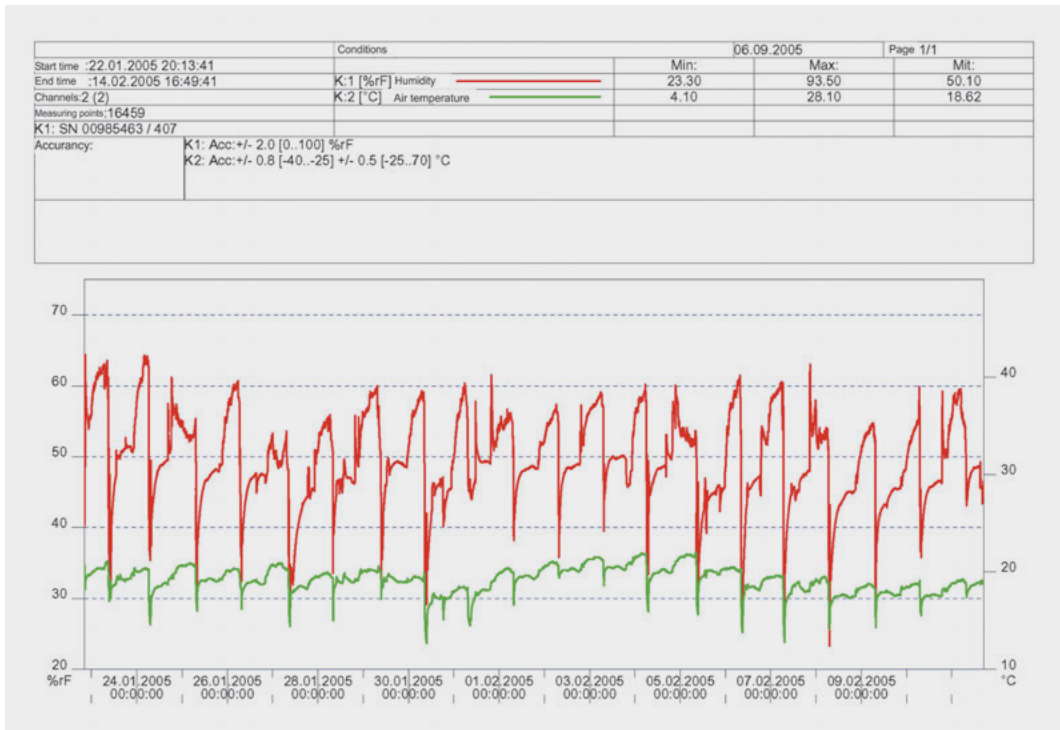
Fig. 7-25 Temperatures and relative humidity during the measurement period, recorded via data logger.

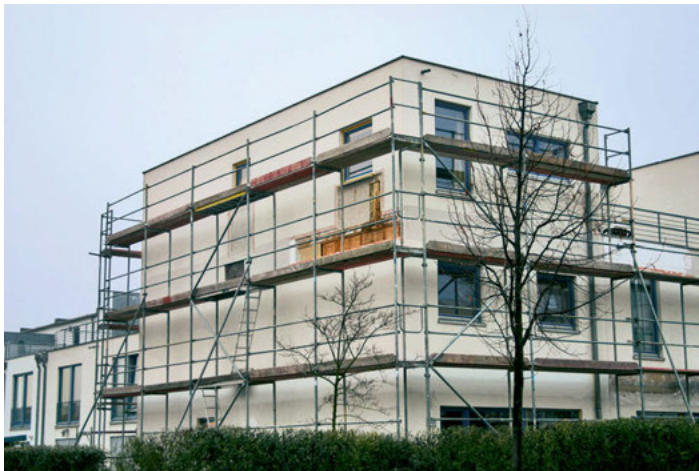
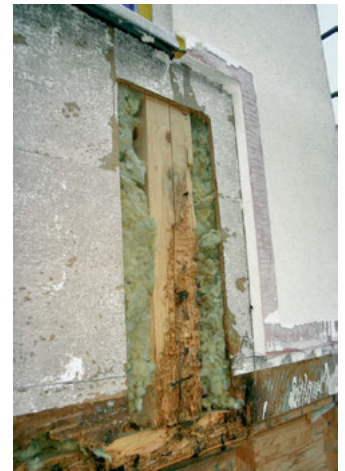
Fig. 7-26 Residence building with exposed examination point in the region of the ceiling slab. The external construction is removed all the way to the thermal insulation.

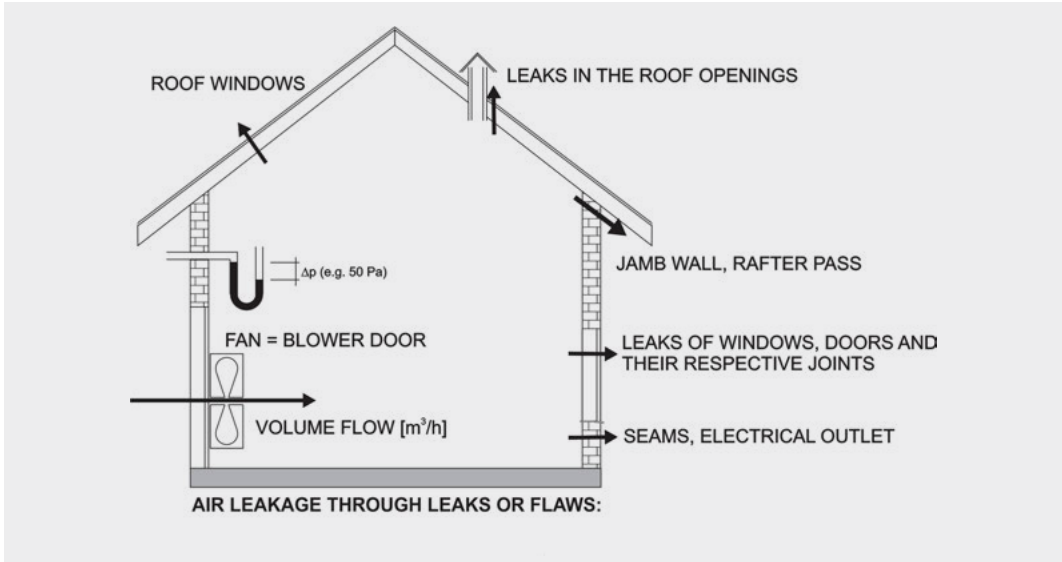
Fig. 7-27 Principle of the differential pressure measurement (colloquially blower door measurement); here, overpressure measurement.

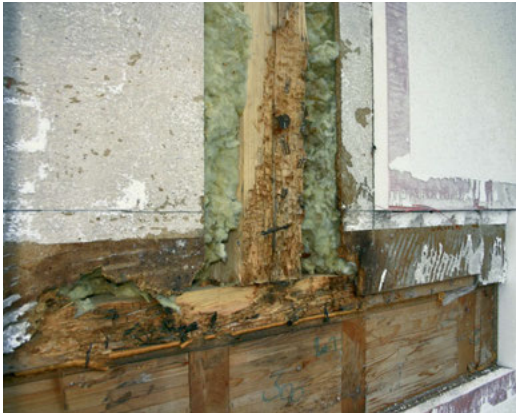
Fig. 7-28 Examination point at zero state (no excess pressure or low pressure).

Subsequently, a blower door test with excess pressure was conducted, causing leakage of warm interior air through surface defects. In order to achieve the highest possible temperature gradient during the additional thermography analysis, the builder-owner had turned up the heaters to the highest level the day before. At potential surface defects, the warm inside air goes through the construction and escapes outside. At this point, the construction grows warm, which can be visualized by means of thermography. This procedure is illustrated in [Figs. 7-28 and 7-30](#).

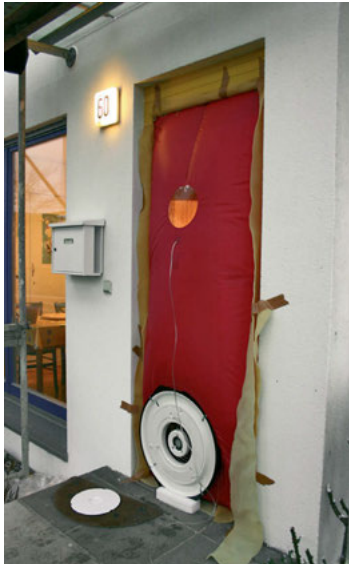
Fig. 7-29 Blower door in position (excess pressure measurement).

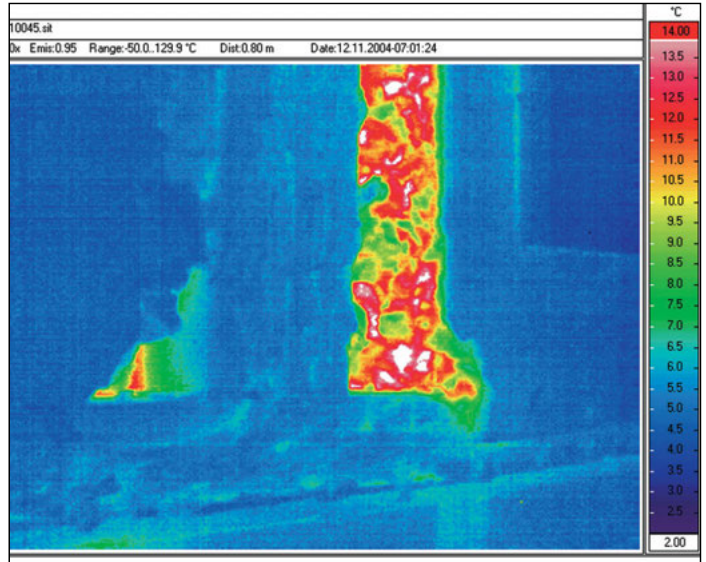
Fig. 7-30 Examination point during the blower door test (implementing excess pressure); the right side of the construction part shows a significant temperature rise compared to **Fig. 7-28**.

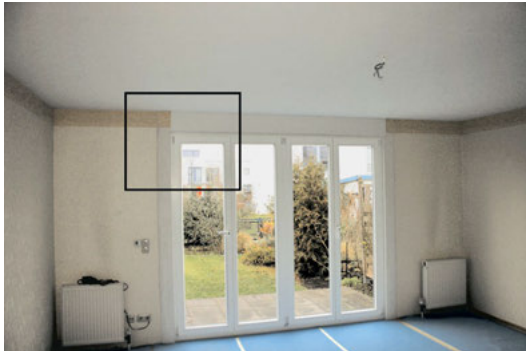
Fig. 7-33 Photograph of the examination area later uncovered within the framework of the thermography analysis.

Thermal image evaluation in combination with a blower door test was conducted on a timber-framed building. For this purpose, the construction was uncovered in the area where the ceiling connects to the wall without destroying the wind proofing or the vapor barrier. Then, with the aid of indoor thermography, the surface temperatures of the region were examined before and during the application of low pressure.

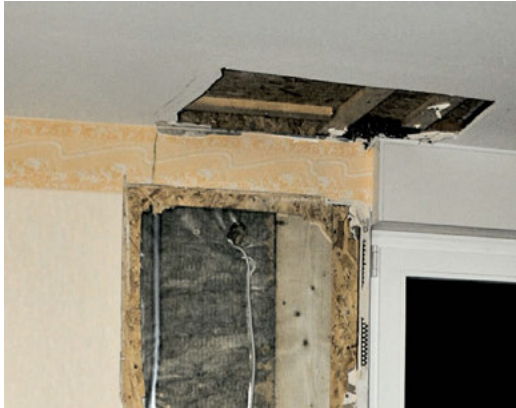
Fig. 7-34 Uncovered examination area between the wall and ceiling and respective thermograms before and during the application of low pressure (about 50 Pa).

The evaluation of the thermal images shown in Fig. 7-34 can be simplified by means of modern IR systems by applying the difference-image technique. Therefore, a temperature distribution is assumed as the subtrahend and is subtracted in the following thermal images as the minuend. The result is the difference between both temperature distributions.

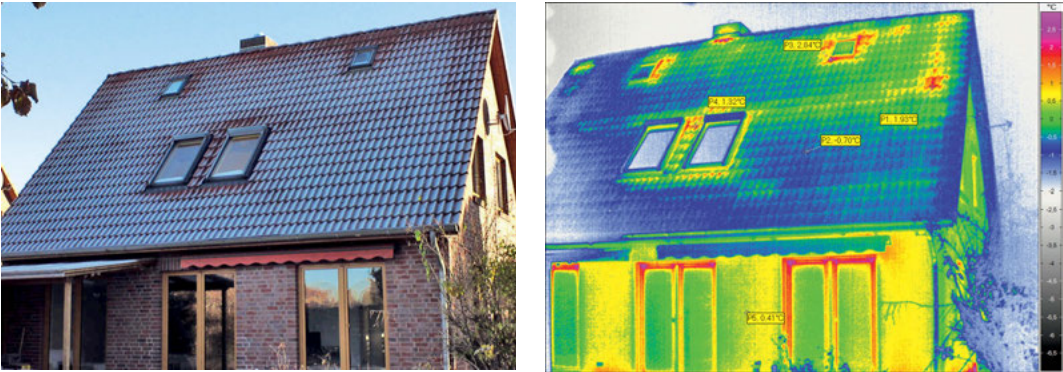
Fig. 7-37 Documentation of heat leakages on a fully heated roof.

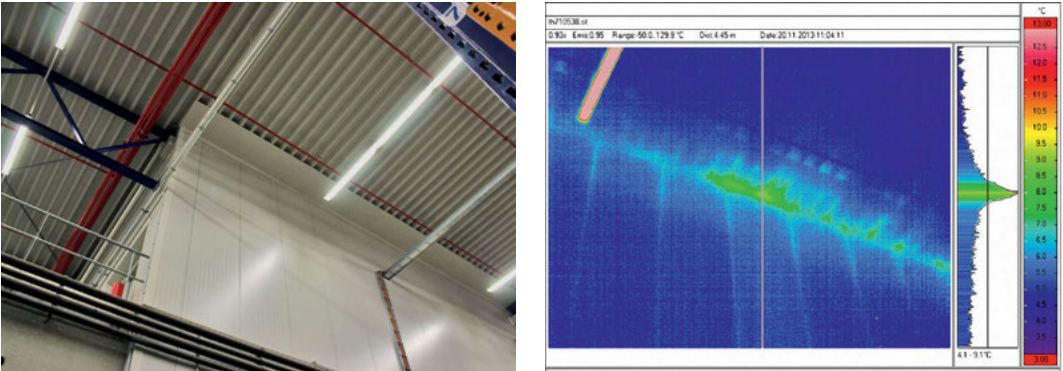
Fig. 7-38 View of the partition wall between the office area (22°C) and the air-conditioned warehouse (+5°C); selective heating in the upper corner area wall/roof.

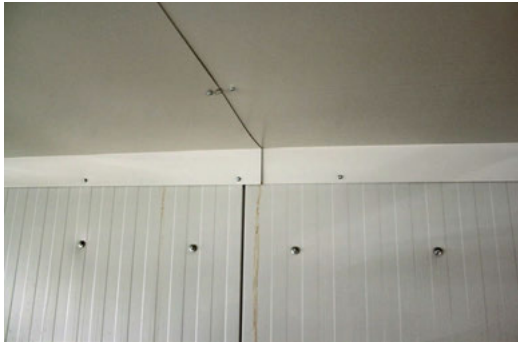
Fig. 7-39 Detail transition wall/ceiling: warm air from the (warm) office area reaches the air-conditioned (cooler) area and condenses there; water run-off traces are the consequence.

first guess as to the cause of the moisture events, leaks in the waterproofing in the roof area were suspected. With the help of thermography, it was proven that the internal partition wall between the office/storage area showed air leaks, which were indicated by conspicuous hot spots in the partition wall area.

The reason for these phenomena was a non-airtight connection of the continuous steel trapezoidal roof between the different climate zones. The warm office air reaches the year-round air-conditioned +5°C area through a slight overpressure of the ventilation system and condenses there. This leads to the detected water run-off tracks.

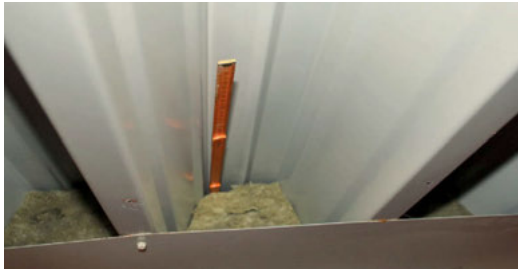
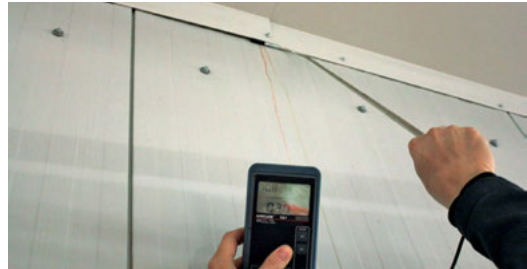
Fig. 7-40 Filling of the bead in the trapezoidal steel sheet without airtight seal, measurement of the natural air emission at the measuring point (here $v = 0.20 \text{ m/s}$).

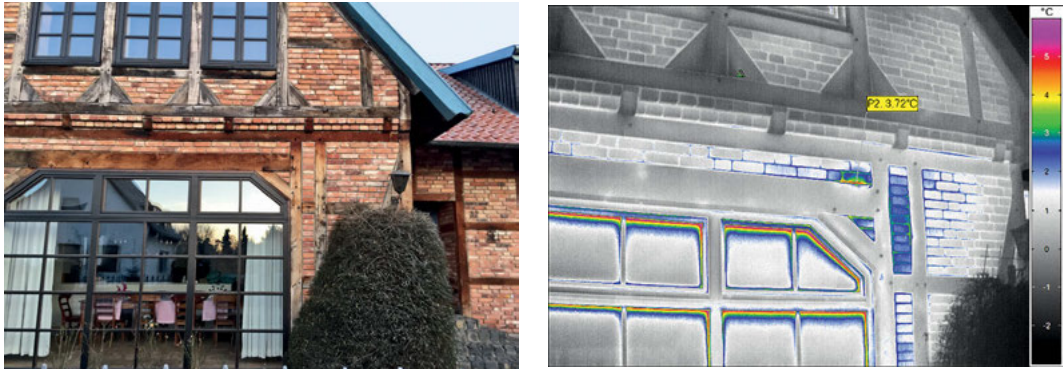
Fig. 7-41 brick lining on a timber-framed wall with documented local air leakage.

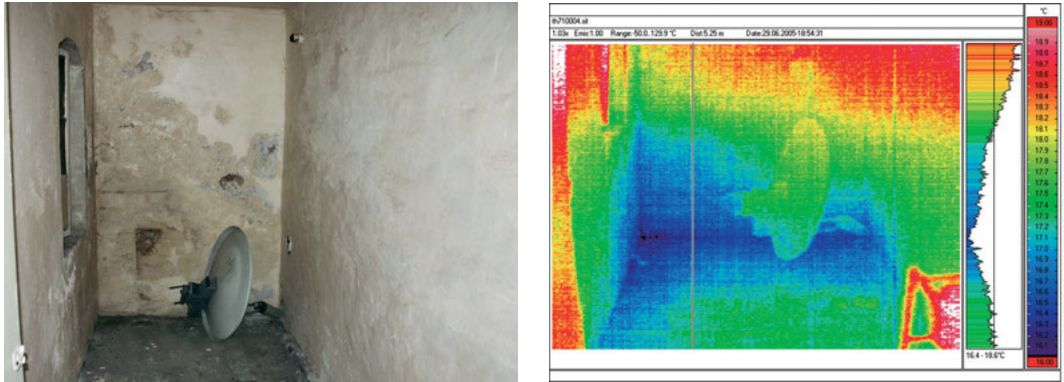
Fig. 7-43 Damp areas of a basement exterior wall; the shape of the moisture horizon is already visually detectable.

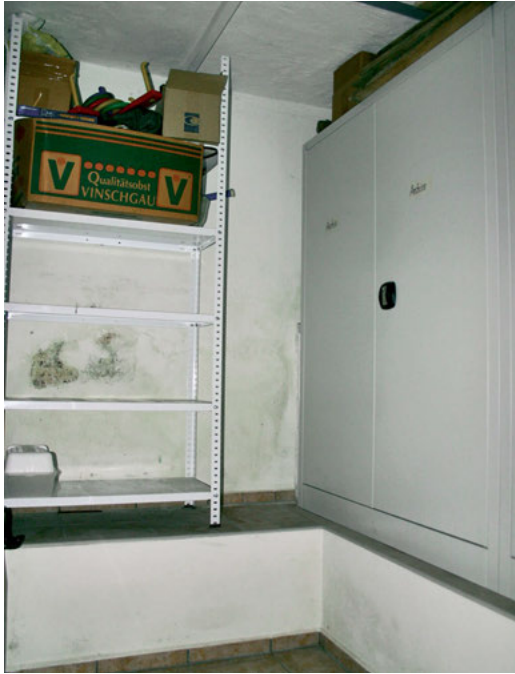
Fig. 7-44 Stains on the plaster show the moisture influence.

As shown in Fig. 7-44, the severely damp region stands out with very low surface temperatures in the thermal image. In addition to the thermal images, the relative moisture distribution of the walls was measured by means of a dielectric measuring device. The measurement of this device is based on the principle of the capacitive electrical field. The measuring field develops between a ball electrode of the device and the mass of the examined area. Fluctuations in the electrical field due to a change of material and/or moisture is digitally displayed in a range between 0 and 199 digits. This is a relative measuring, which means that the displayed value is not the absolute moisture content in g/cm^3 but only a value indicating the dimension of the construction element's moisture content considering the gross density of the material.

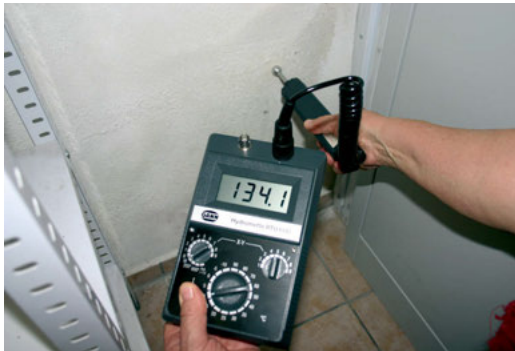
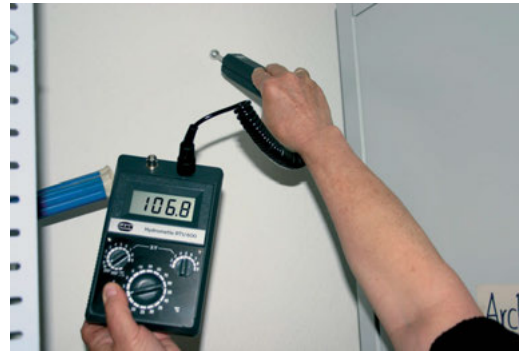
Fig. 7-45 Measuring the moisture, in the lower wall region about 134 digits, in the higher (drier) wall region about 107 digits.

It could be seen that the measuring values of the dielectric measuring device obtained at different heights of the basement walls coincided to a relatively high degree with the colder surface regions captured by means of the thermal imaging technique.

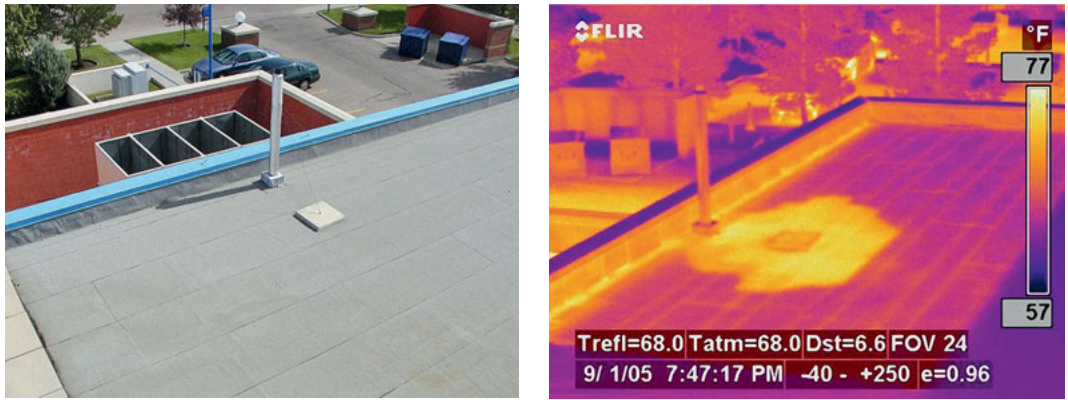
Fig. 7-46 Documentation of a leakage on a flat roof (source: with kind support of FLIR Systems GmbH, www.flir.com).

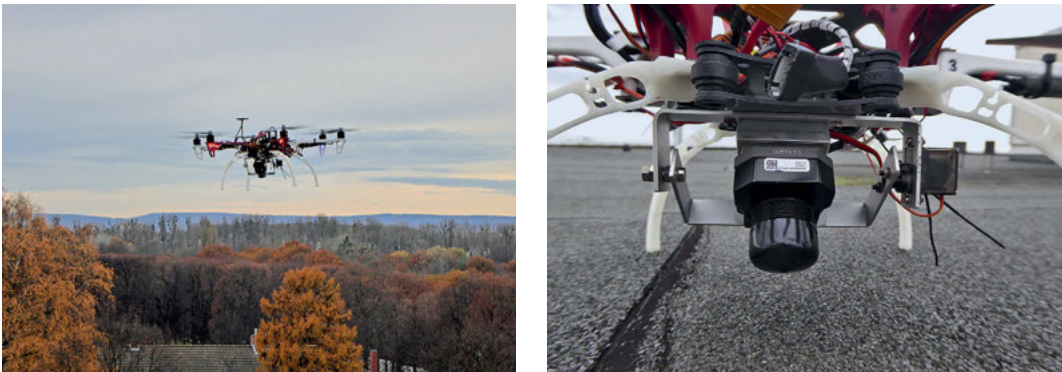
Fig. 7-50 Drone system (manufacturer DJI) with thermal camera Flir Tau2 (company Teax).

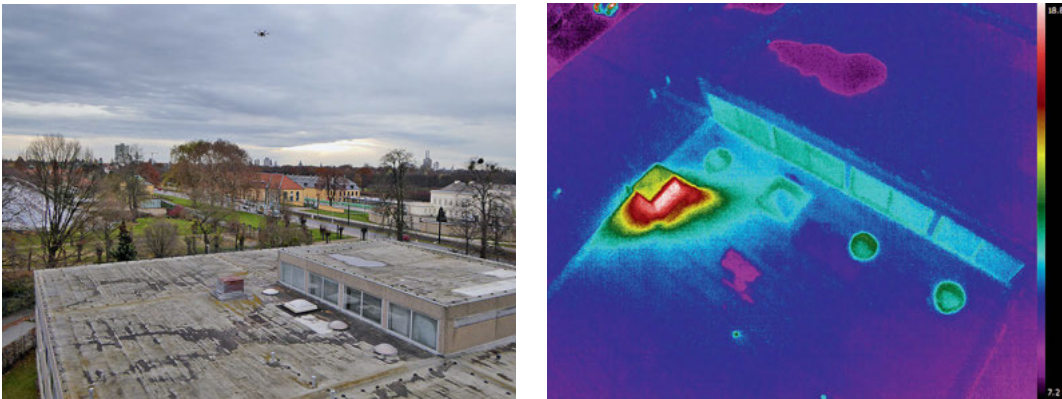
Fig. 7-51 Thermogram with the aid of a remote-controlled drone: hot spot in the area of an exhaust ventilation system; (top left) the drone can be seen in flight.

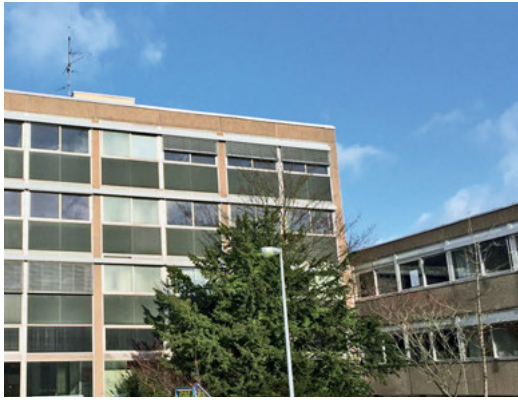
Fig. 7-52 Thermogram generation with the help of a remote-controlled drone (clear picture was taken from the ground view on another day).

This drone was flown by remote control; the thermogram transmitted live to a monitor. It was determined that at least two people must be present during such a thermography: one to operate the drone, and a second to interpret the live image and give feedback to the operator on the drone's position and any instructions to redirect the drone.

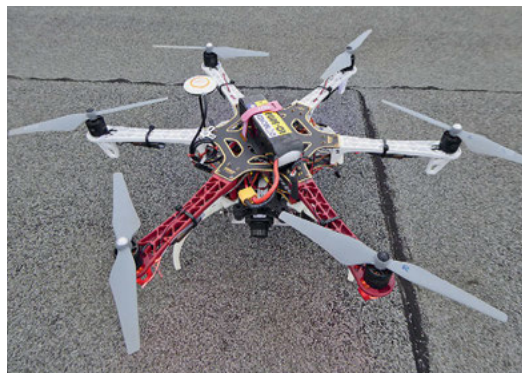
Fig. 7-53 Live image transmission from the drone to the monitor (*left*); view of the drone (*right*).

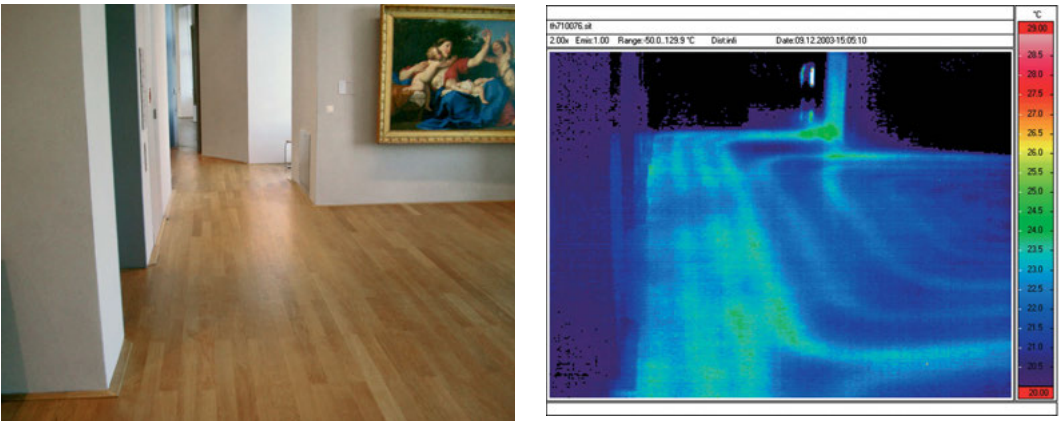
Fig. 7-54 The characteristic geometry of the underfloor heating pipe run becomes visible in the thermogram.

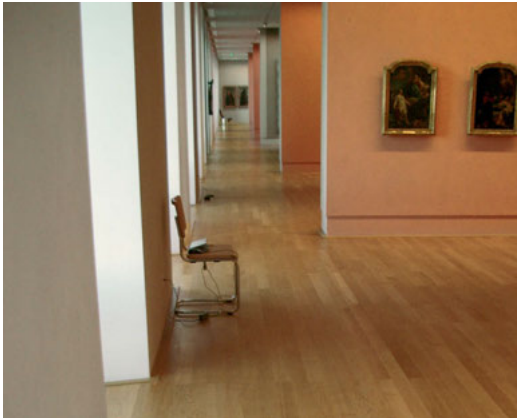
Fig. 7-55 The location of the warmer flow is clearly visible on the right side of the hallway.

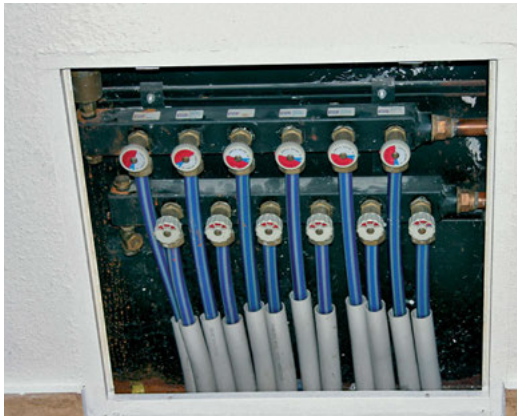
Fig. 7-56 An underfloor heating distributor; one valve of the pipes (second from left) is unopened.

In addition, it should be mentioned that the pipes attached to the heating distributor can also easily be checked (Fig. 7-56).

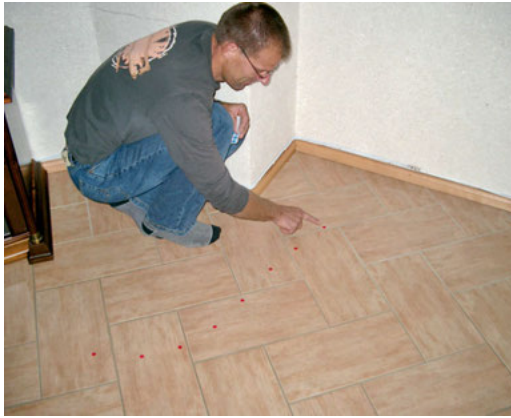
Fig. 7-57 Pipe run shown under the parquet floor (*right*). The location of the heating pipes is documented with the aid of glue dots on the floor (*left*).

For the installation of a fireplace within a living room with underfloor heating, a load-bearing construction of corings from the fireplace down to the ground slab had to be drilled. In order not to damage the underfloor heating, the pipe run had to be known in advance. With the aid of thermograms, the flow and return pipes were localized and the layout of the pipe run was documented on the floor with glue dots (Fig. 7-57). Due to the heating process, flow pipes

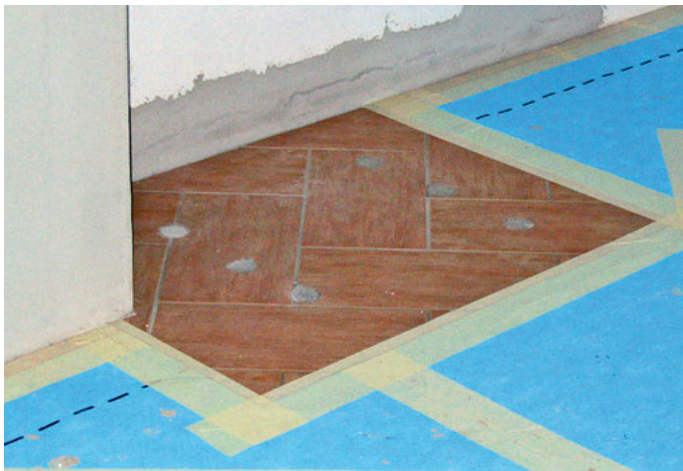
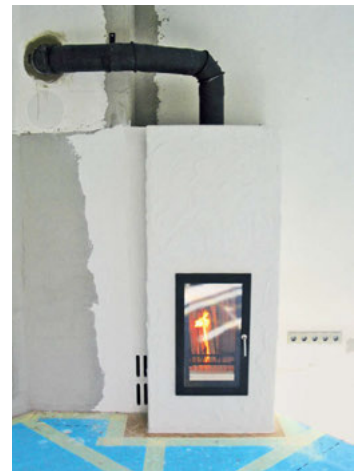
Fig. 7-59 Arrangement of the coring to transfer the weight of the fireplace to the ground slab (*left*); first heating of the installed fireplace (*right*).

become visible quickly and clearly; return pipes, which are placed between the flow pipes, become dimly visible only after a delay (Fig. 7-58). As a result, it was decided to place the corings relatively close to the highly visible flow pipes. The corings were made without any damage, and the fireplace was installed (Fig. 7-59).

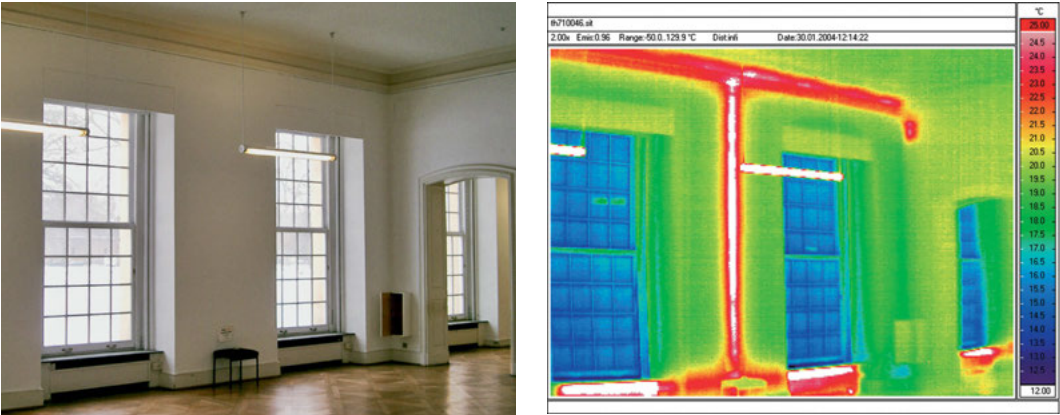
Fig. 7-60 The thermogram clearly shows the supply pipes of the heating system on the wall surface.

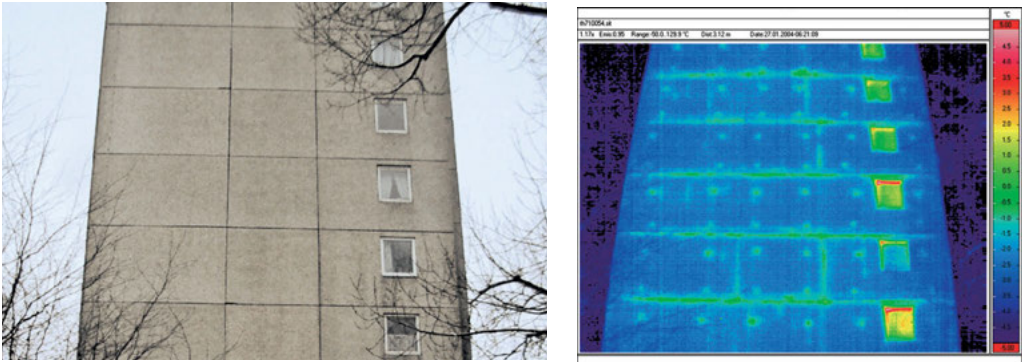
Fig. 7-62 In the thermal image, metallic construction parts are visible through the weatherproof layer as points of elevated surface temperatures.

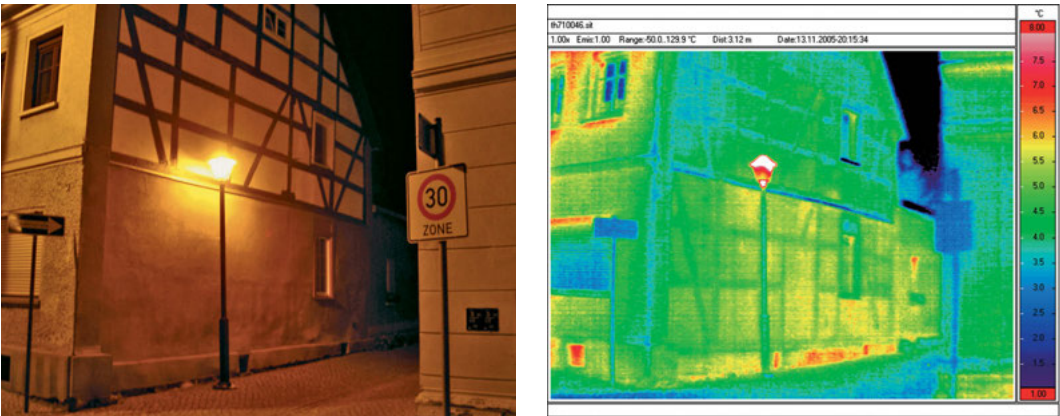
Fig. 7-64 Visualizing concealed timber frame constructions by means of thermography (image taken in November).

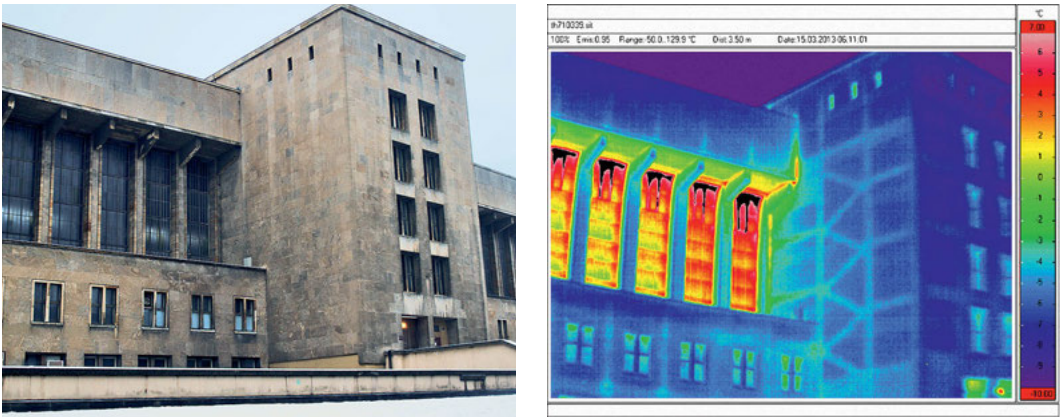
Fig. 7-66 Thermographic visualization of reinforced concrete structures under natural stone slabs.

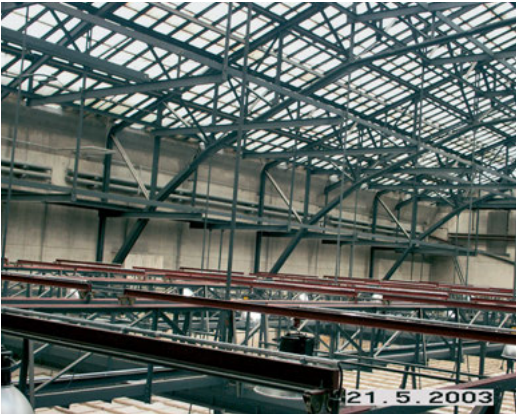
Fig. 7-68 Tied arch construction of an open-sided floor.

It was shown that the thermal layering of the well-ventilated open-sided floor has led to temperature differences within the construction's load-bearing components.

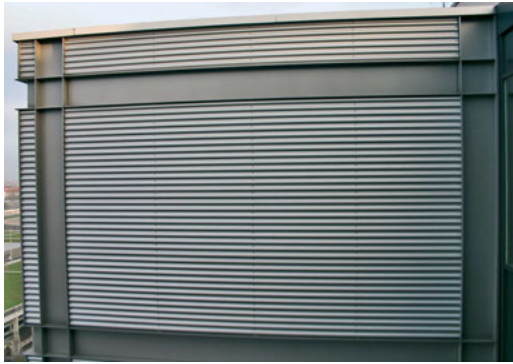
Fig. 7-70 View onto the rear-ventilated facade construction made of corrugated sheets. The angle of perspective changes continuously between 0° and 90° from one corrugation to the next (also see Fig. 2-14).

A rear-ventilated facade construction was installed on an exterior wall. The metal sheet construction, consisting of corrugated sheets and non-bearing pilaster strips, is mounted on a subconstruction which itself is mounted on a massive load-bearing concrete wall by means of point load-bearing anchors.

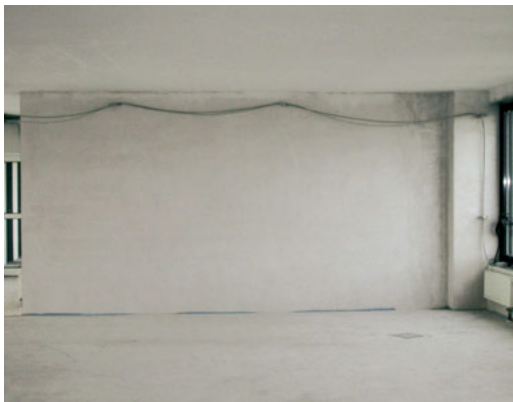
Fig. 7-72 Indoor thermography of the exterior wall shown in Fig. 7-70.

The indoor thermography of the wall (see Fig. 7-72) reveals a checkered distribution of the inside surface temperatures. The blue areas signify cooler regions with higher thermal transition due to the installed point anchors. This example clearly shows the effect of the freely customizable color range, since the effective temperature difference between the blue (cooler) and green (warmer) areas is about $\Delta\theta \approx 0.7 \text{ K}$.

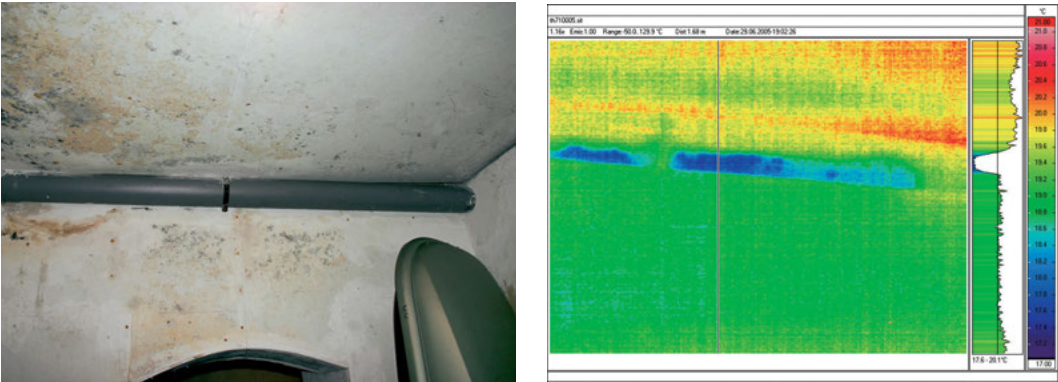
Fig. 7-73 Drain pipe congested with leaves. The pipe drains a gutter installed on the terrace above the basement ceiling.

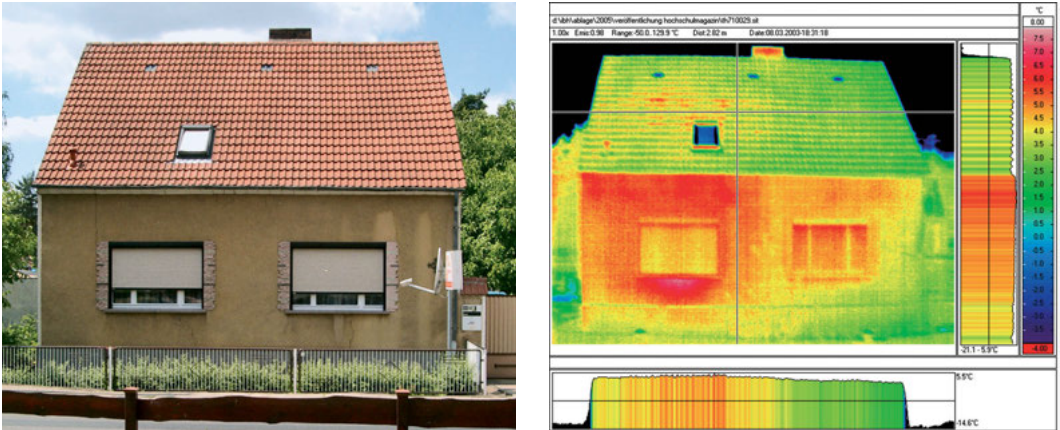
Fig. 7-74 Thermal image before the energy-focused building refurbishment (March 2003).

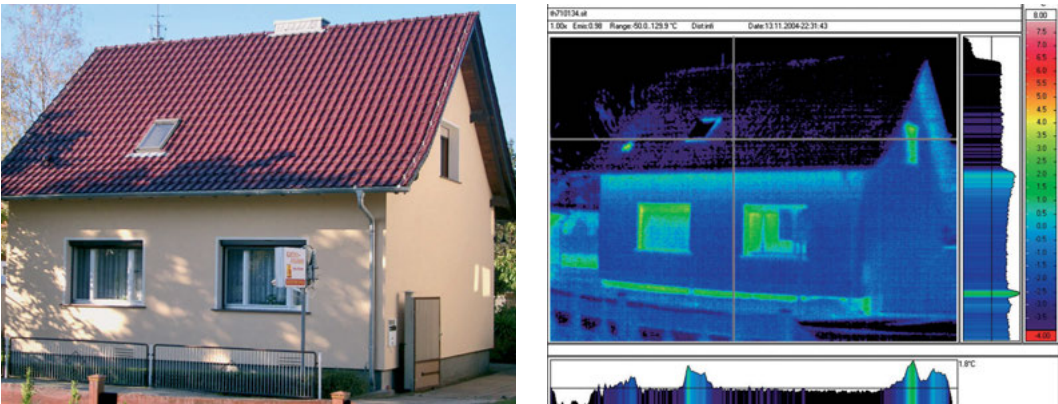
Fig. 7-76 Thermal image after adding thermal insulation onto the roof (20 cm, thermal conductivity 0.045) and onto the exterior walls (10 cm, thermal conductivity 0.040 W/(mK)). The plinth beam was not insulated at the time of the measurement (November 2004).

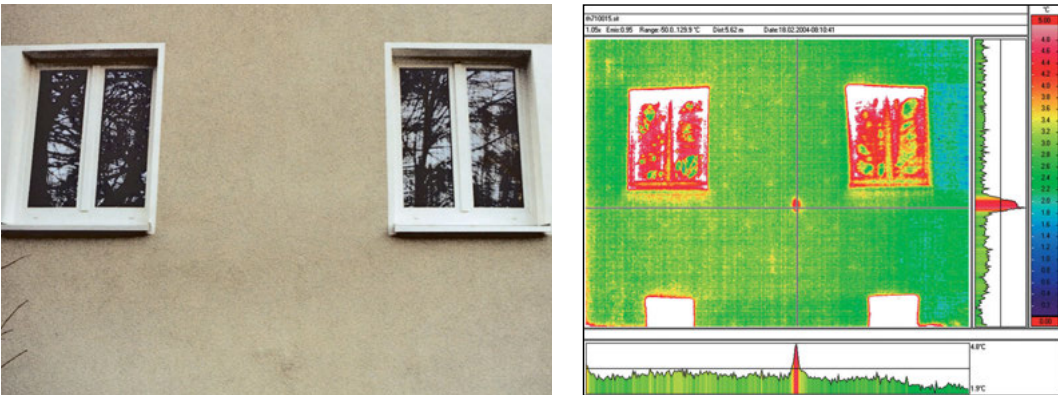
Fig.7-79 More detailed picture of the anomaly detected in Fig. 7-78: the elevated surface temperature θ_{se} between the windows stands out against the rest of the facade (measured temperature: 4.4°C).

The following images can be used to explain the so-called distance effect emerging in thermography systems: the surface temperature θ_{se} determined from the thermogram depicted in Fig. 7-78 is about 3.6°C. When decreasing the measuring distance, the surface temperature

θ_{se} increases to 4.4°C (Fig. 7-79) and 6.2°C (Fig. 7-80). This is not a measuring error, but is due to the fact that the size of the real measuring area assigned to one pixel of the thermography system's receiver unit increases with the measuring distance. Hence, the integration over the area is finer and more detailed for close-up images (see Fig. 3-11). This is the reason for the different surface temperatures determined in the case below (outdoor thermography of a thermal bridge).

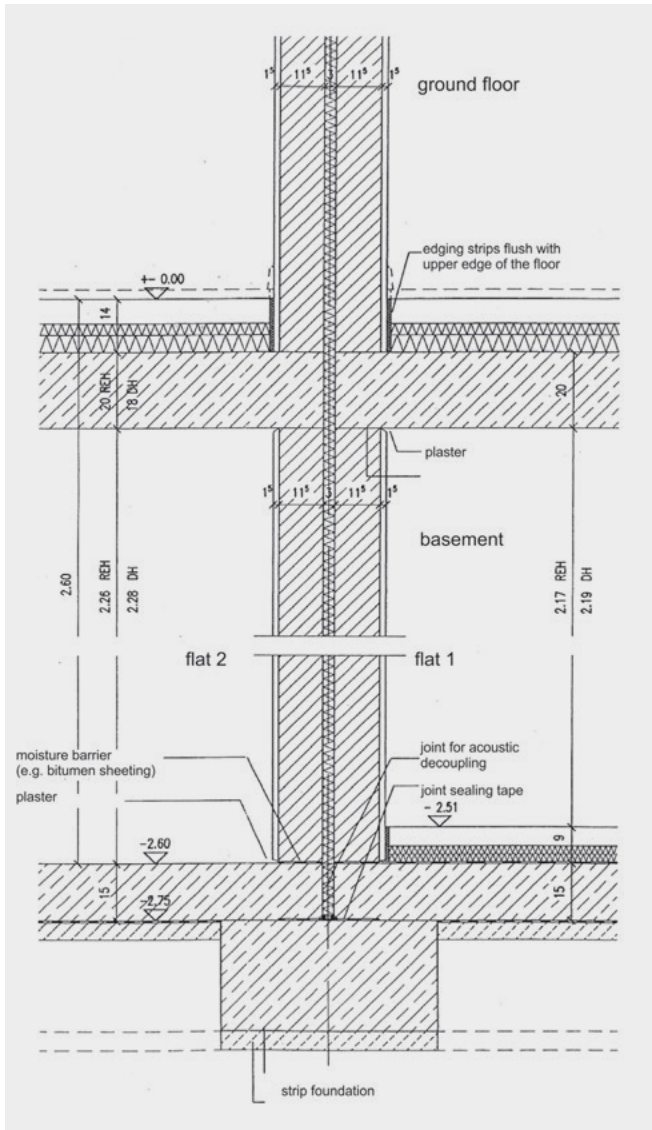
Fig. 7-81 Planned construction of the terraced house partition walls.

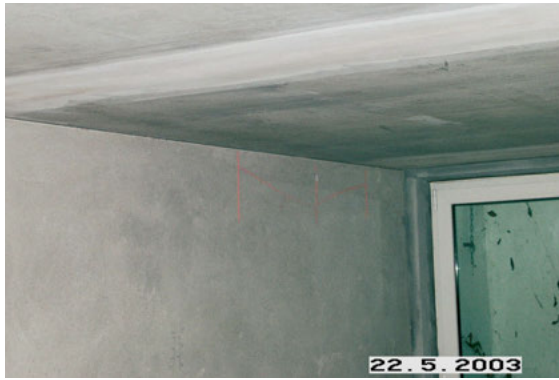
Fig. 7-82 Joint of the basement concrete ceiling and the masonry partition wall, elevated surface temperature near the window: a subsequent uncovering of the construction part revealed missing thermal insulation and clumps of concrete at the height of the ceiling.

The evaluation of the thermal images revealed local hot spots in areas where missing insulation or sound bridges had previously been discovered by endoscopic examination or exposure of the structure (see Fig. 7-82). With the help of the thermographic examination, numerous other critical sound bridges were detected and later removed in this construction project.

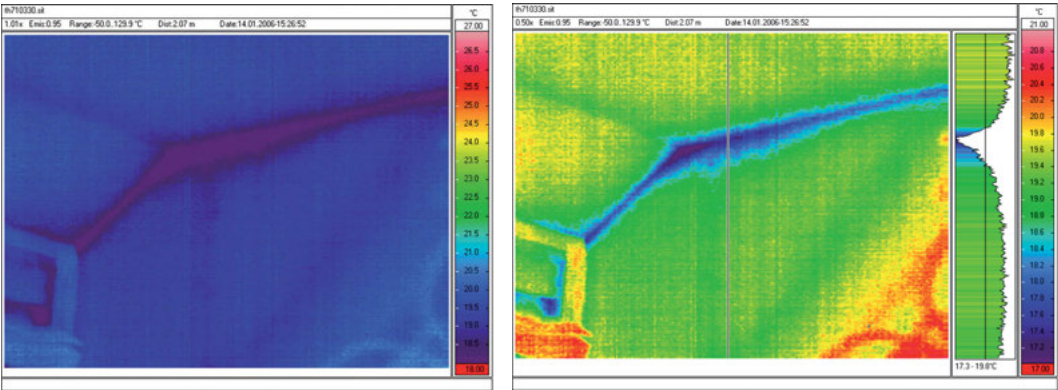
Fig. 7-84 Inspection of the fixed defect shown in Fig. 7-83: (left) for the same temperature range used in Fig. 7-83, it is impossible to interpret the thermal image; (right) using an appropriate temperature scale, the cooling in the edge between wall and the ceiling is smooth; the temperature difference is only about 2.5 Kelvin.

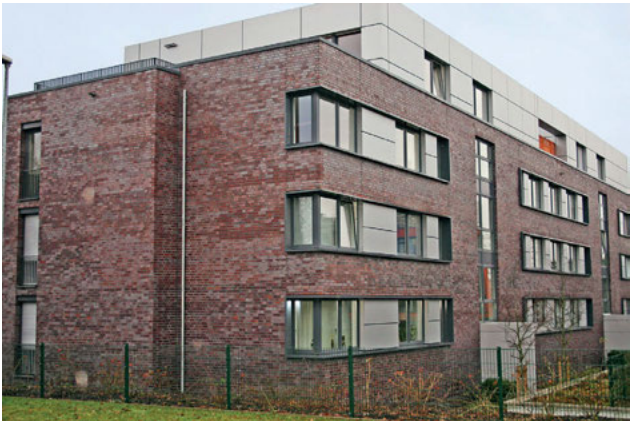
Fig. 7-86 Overview of the apartment building with brick facing: The renter complained about mold formation at the transition between the window frame and the reveal.

The renter of an apartment complained about mold formation in the transition between the window frame and the reveal in his bedroom (Fig. 7-86). Within the framework of an evaluator’s report, it had to be investigated whether the mold formation had been caused by defects within the construction or by the renter’s negligence. Thermography was used for the examination, among other measuring techniques. Both indoor and outdoor thermography were conducted.

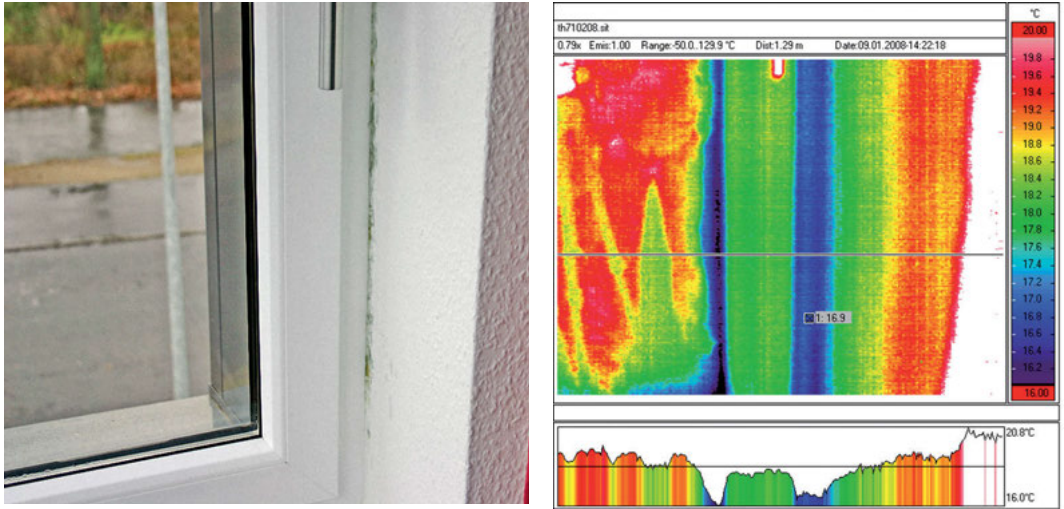
Fig. 7-87 Transition between the reveal and the window frame: the temperature distribution is remarkably cold. Note: due to the reflection of the window, the person conducting the thermography measurement often becomes visible in the thermal image.

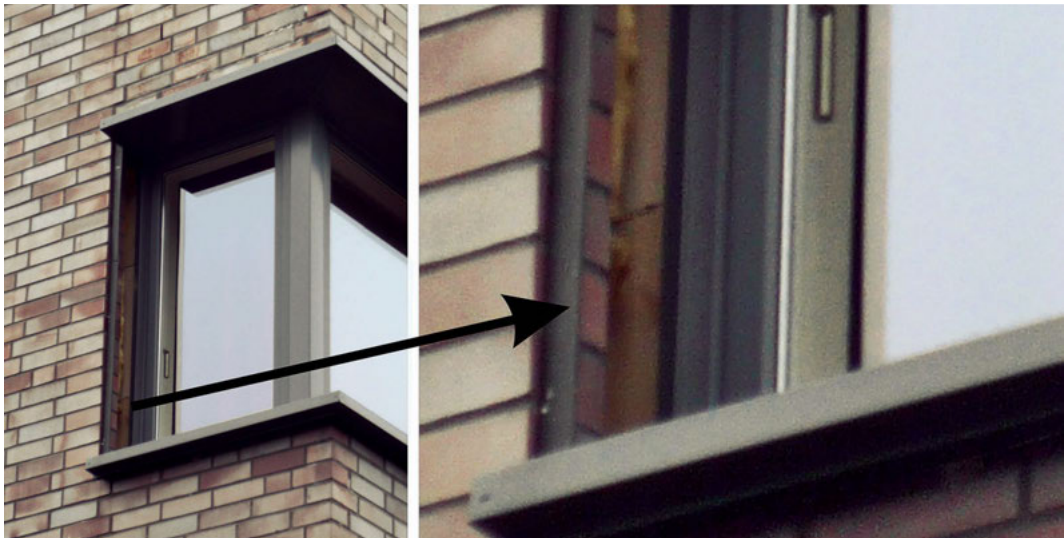
Fig. 7-88 Uncovered exterior cover plate: (right) close-up of the detail, showing that the thermal insulation had not been fit properly to the reveal.

As a consequence of the expert’s report, the construction company removed the exterior cover plate of the reveal and discovered that the thermal insulation had not been fit all the way to the reveal (see Fig. 7-88). The conclusion drawn from the thermography measurement was proven to be correct.

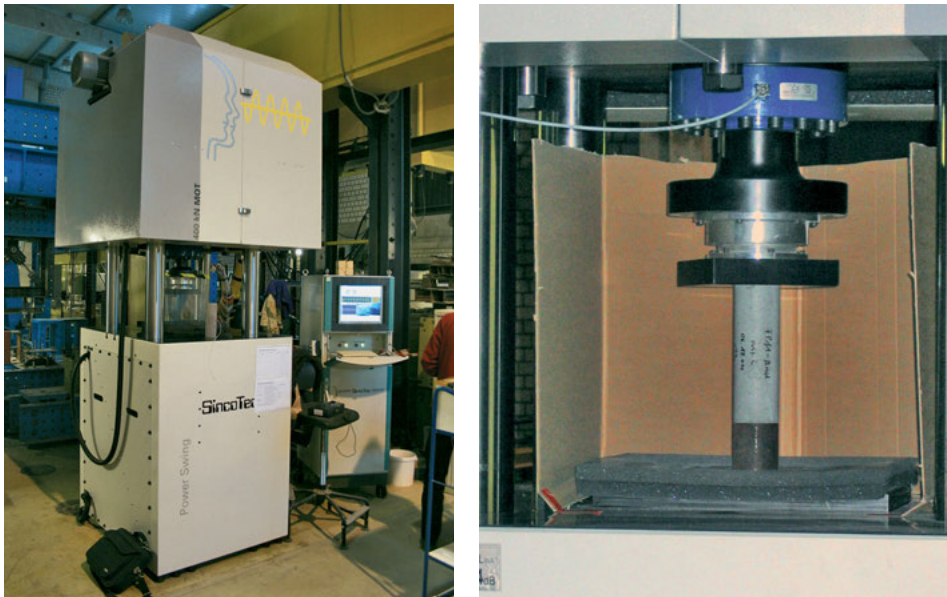
Fig. 7-91 Hydraulic press and concrete specimen.

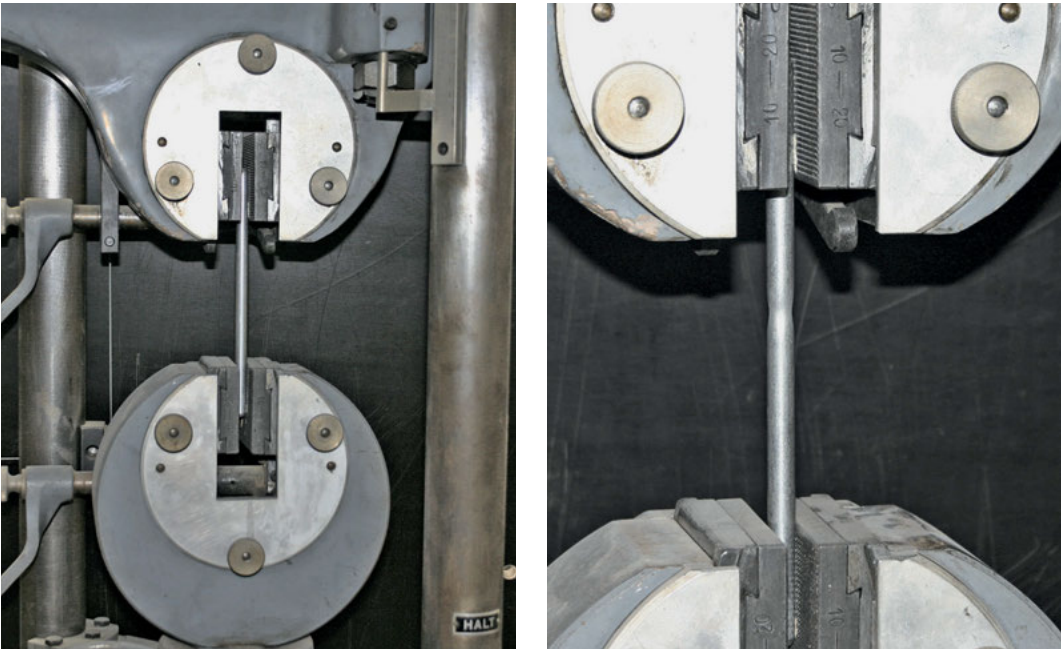
Fig. 7-93 Tensile test of a steel plug, showing contraction at the place of subsequent failure (fracture cone).

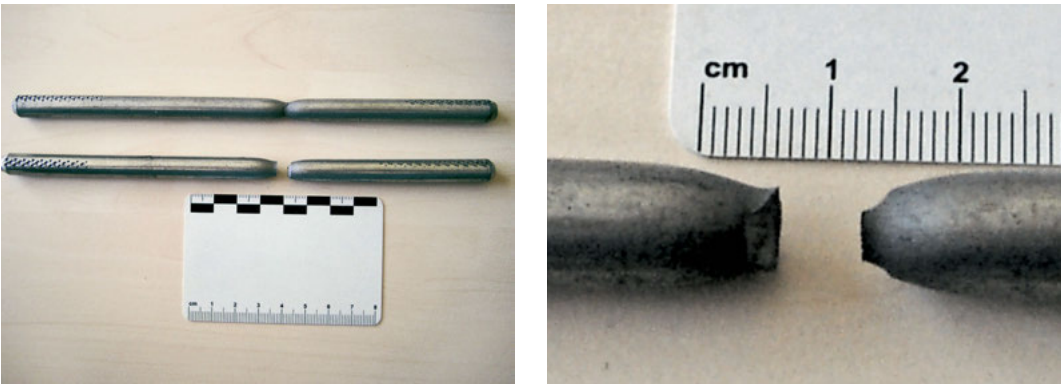
Fig. 7-94 Close-up of the fracture cone.
