Torsten Richter, Nabil A. Fouad

Guidelines for Thermography in Architecture and Civil Engineering

Theory, Application Area, Practical Implementation

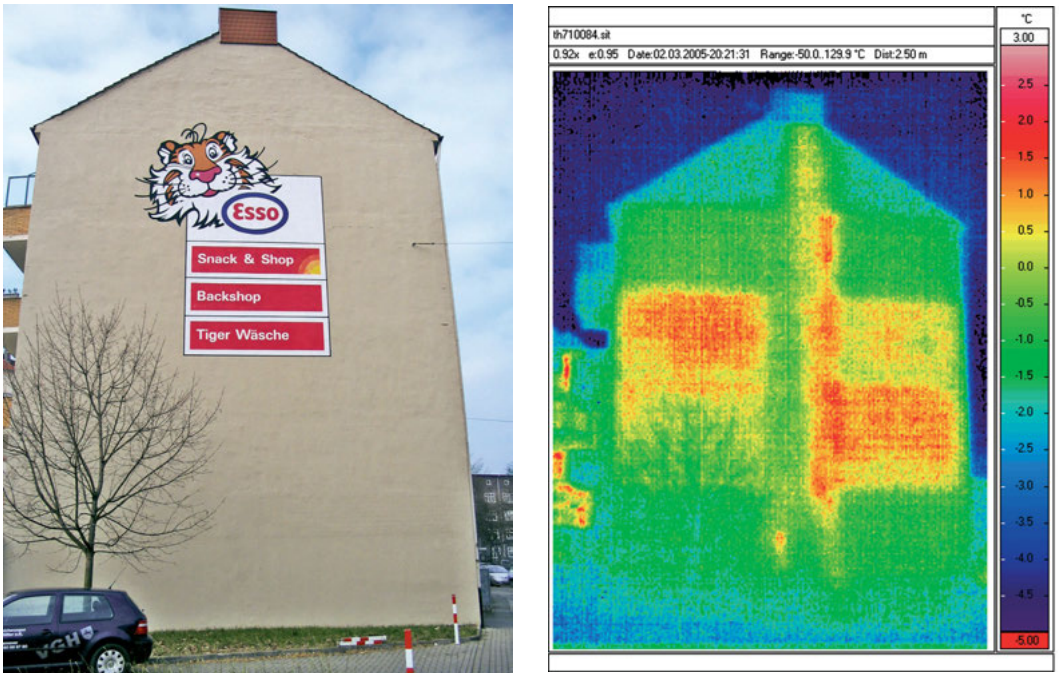
Fig. 8-1 Old building with typical checkered pattern in the thermal image.

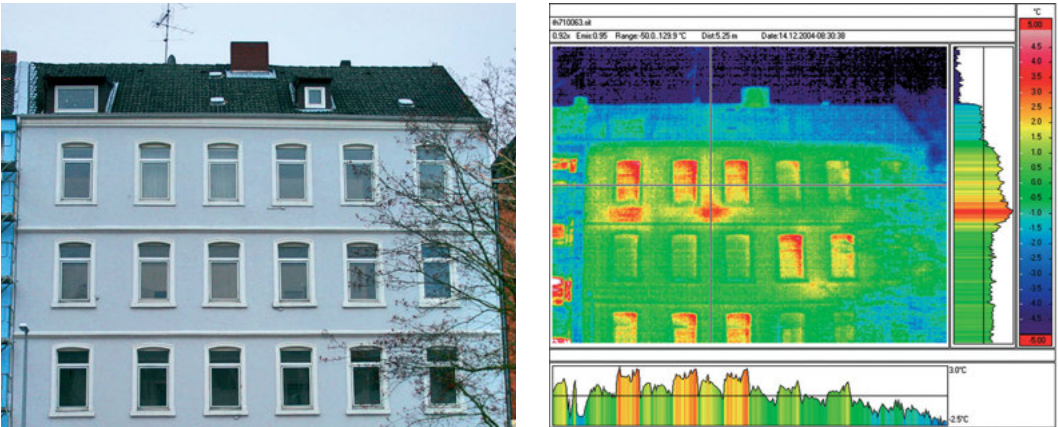
Fig. 8-2 Old building with the location of the heaters clearly standing out (here: electrical night storage heater).

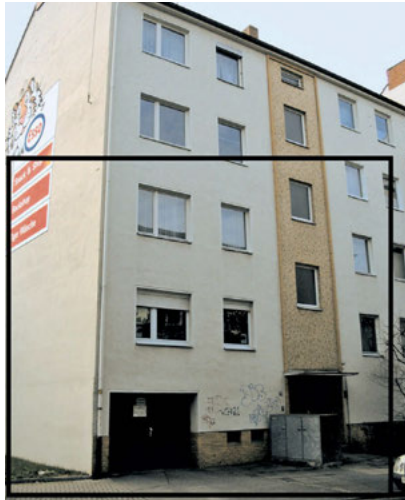
Fig. 8-3 Thermal image of an old building clearly showing the radiator and the heating pipe. On the 1st floor above the thoroughfare, the difference between the wall with additional interior thermal insulation (*left*) and the original wall with the windows (*right*) is visible.

In many cases, the exterior walls of (mostly) old buildings exhibit hot spots. There are two reasonable explanations for this phenomenon; the hot spots are either indicators of thermal bridge effects or, as is more often the case, they indicate the location of the heaters installed inside the building. Due to the relatively high heat demand of old buildings, the heating system has to generate a lot of heat, which due to the poor thermal insulation also results in higher thermal losses through the exterior walls. This phenomenon becomes even more striking when heaters are installed in niches, since the exterior wall is even thinner in these areas. If the heating pipes are installed within the exterior wall construction, they become apparent in the form of vertical lines (see Fig. 8-3).

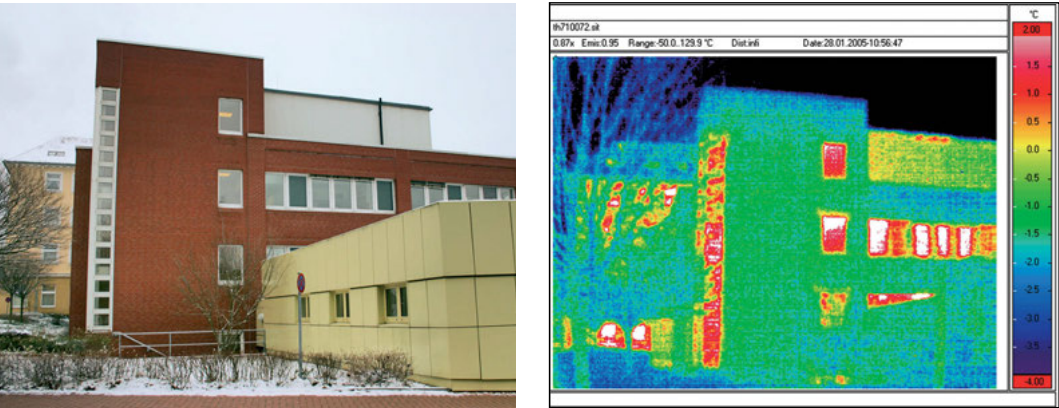
Fig. 8-5 Rear-ventilated wall construction. Due to the homogenization of the rear-ventilated facing, there are hardly any visible temperature differences.

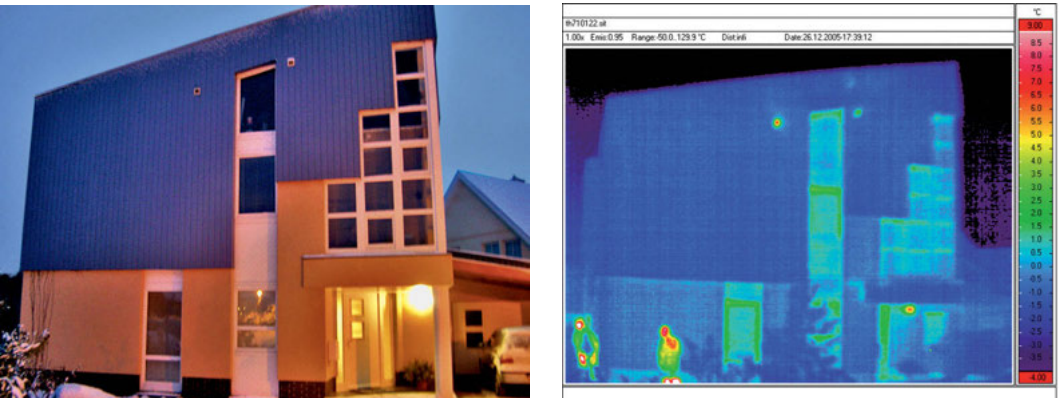
Fig. 8-6 Example of a rear-ventilated cladding in the upper part of the building.

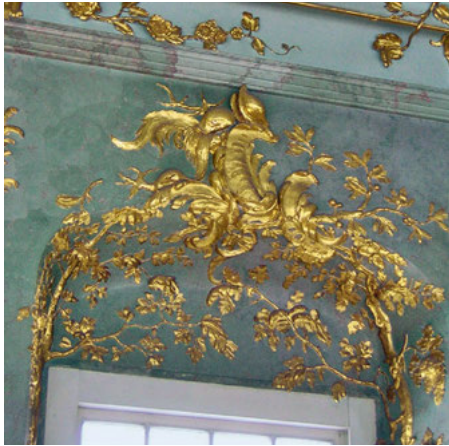
Fig. 8-8 Transition between wall and ceiling of a historical building; wood cladding with ornaments.

The problem of the temperature homogenization of rear-ventilated constructions described in Section 8.1.3 can also be observed at constructions with interior cladding. The thermal images obtained from an indoor thermography do not allow for conclusions about the situation behind the cladding. In this example, the cladding is decorated with golden ornaments. For further information on how to interpret the surface temperatures of the ornaments shown in the thermal image, see the explanation on emissivity ϵ discussed in Chapter 2.1.2.

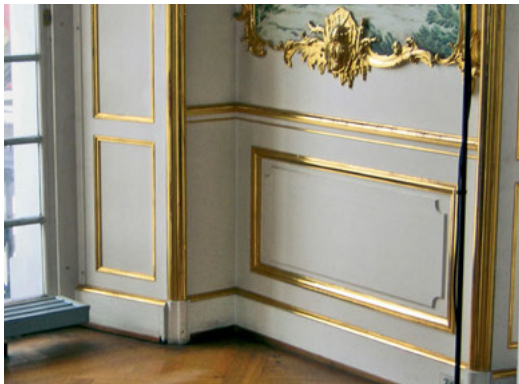
Fig. 8-9 Wood cladding in a historical building: details of the construction concealed behind the cladding are undistinguishable.

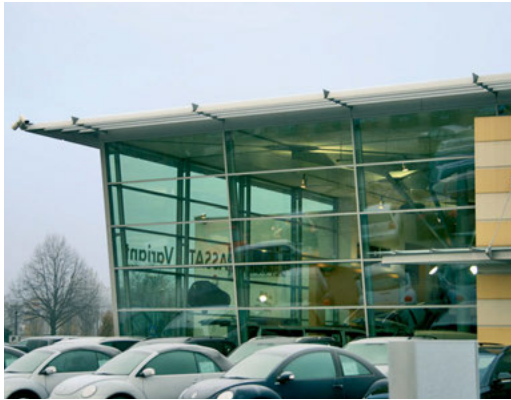
Fig. 8-10 Extensively glazed showroom: the thermogram is simplified with an emissivity ϵ of 1.

Typical examples of extensive glazing are showrooms of car dealerships. A characteristic thermogram of such a building is shown in Fig. 8-10. The elevated temperatures in the area around the post and mullion construction are remarkable. In order to determine more precise absolute temperature values, the input of the emissivity ϵ and the ambient temperature θ_u is necessary. Yet the indication of precise absolute temperature values of the extensive glazing shown in the picture is not that simple. In addition to the reflection properties and emissivity, the glazing's transmissibility also has to be considered for shortwave infrared systems (wavelength range of 3–5 μm).

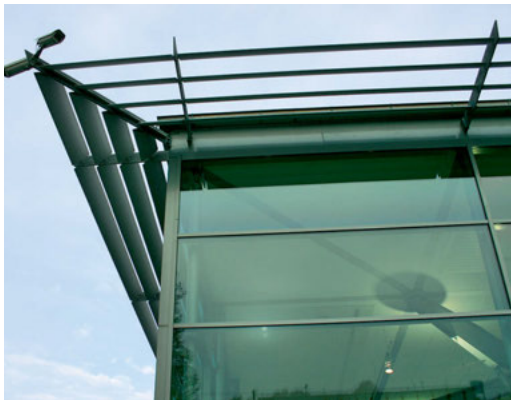
Fig. 8-11 Detail of the corner area: again, the thermogram is simplified with an emissivity ϵ of 1.

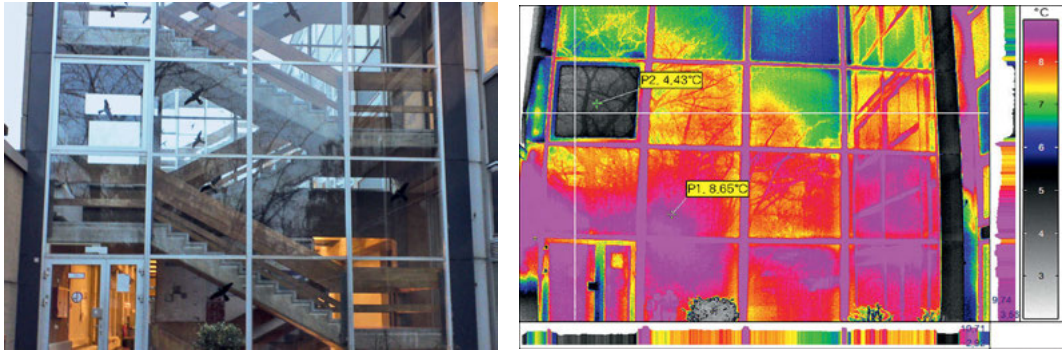
Fig. 8-12 Thermogram of a glazing in a staircase, in which one window was retrofitted to be openable. This window has insulating glass, whereas the other fixed windows have only a single glazing.

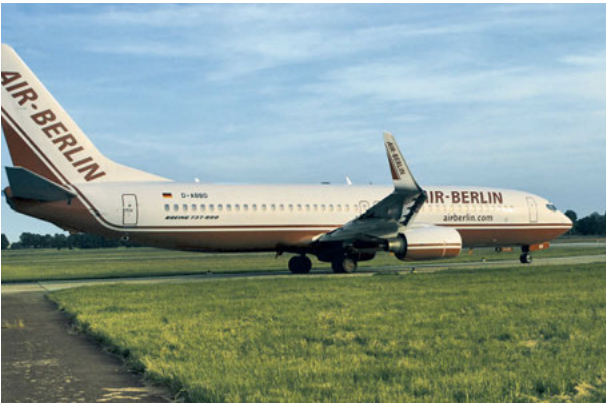
Fig. 8-16 Thermal image of a Boeing 737-800.

The area around the main landing gear of the aircraft shown above exhibits elevated temperatures due to the braking maneuver. Moreover, it can be seen that the temperature of the engine exhaust is beyond the present measuring range of the thermography camera (max. +120°C). For this field of application, the temperature range of the camera would have to be changed.

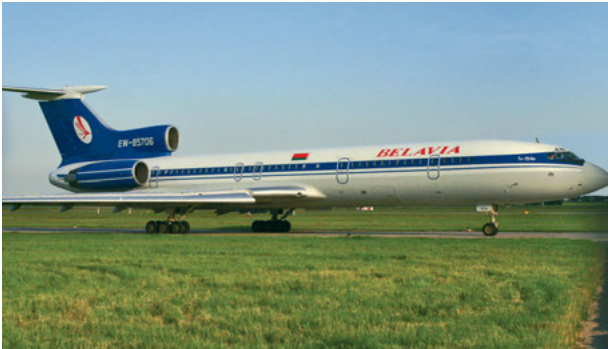
Another aircraft is shown in a thermal image in Fig. 8-17. At the aircraft body and the extended wing flaps, the effect of the angle dependence of emissivity on the temperature displayed in the image is visible. As in the thermal image shown above, the brakes of the main landing gear are heated. Another hot spot, which is caused by an exhaust opening of the aircraft's air-conditioning system, can be seen at the transition between the aircraft body and the wing.

Fig. 8-17 Thermal image of a Tupolev 154-M.
